ONE CENTURY OF STUDIES FOR THE PRESERVATION OF ONE OF THE LARGEST CATHEDRALS WORLDWIDE: A REVIEW

Ahmed Elyamani¹ and Pere Roca²

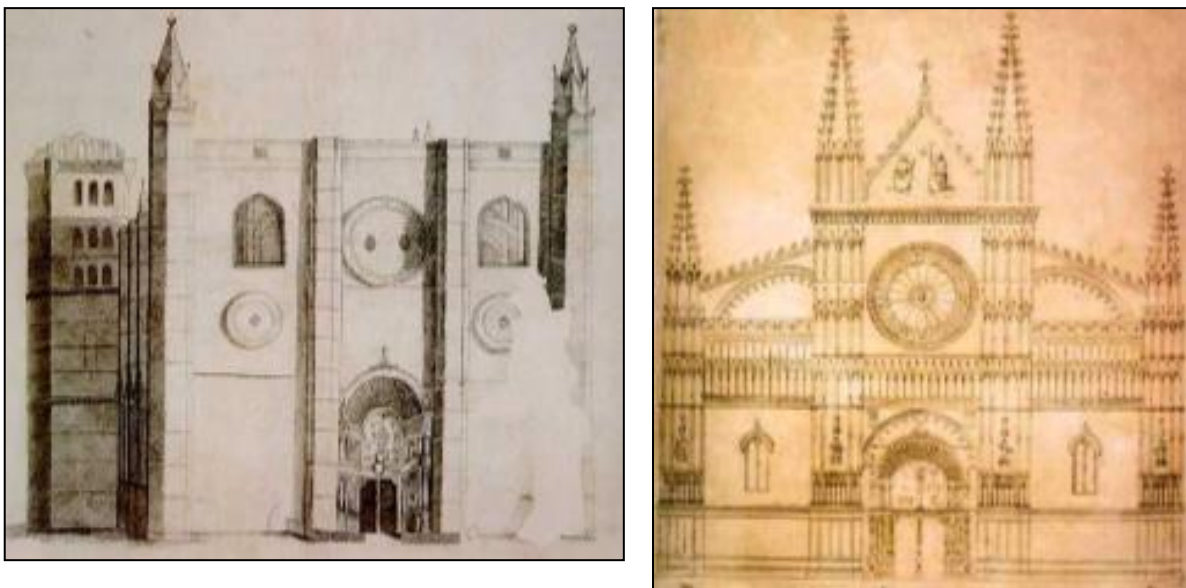
The third period can be called the reconstruction period. The first structural problem started in 1639 and the last important dismantlement was for the west façade in 1851. Thereby, this period lasted from 1639 to 1851. In this period, many parts of the cathedral failed or manifested critical cracking so that it was decided to dismantle and rebuilt it again. In the

17th century, some of the vaults and arches collapsed and were reconstructed. The earthquake of March 18th, 1660 resulted directly in the failure of two arches and initiated the out-of-plumb overturning of the west façade. In the 18th century, some vaults suffered from severe cracking and large deformations, furthermore some of them collapsed, therefore, they were reconstructed. In addition, six flying arches were propped. In Roca and González (2001) a discussion is given about possible reasons of this intervention and the real necessity of it. Till the mid of the 19th century, the main concern was about the west façade only and other structural elements didn't show any collapses. The out-of-plumb of the west façade increased from 80 cm near the mid of the 17th century to 90 cm at the beginning of the 19th and reached a very alarming value of 130 cm and it

was essential to demolish it. The earthquake of 1851 affected the already deteriorated west façade.

Figure 4. The west façade: comparison between the original façade (left) and the new façade of Baptist (right).

The fourth period extended from 1851 to 1888 and was mainly focused in the dismantling and reconstructing the west façade. The new façade had a flamboyant neo-Gothic style and was very different from the old façade and also from the rest of the cathedral, Figure 4. The buttresses' sections were significantly increased with respect to the former ones. The reconstruction works finished in 1888.

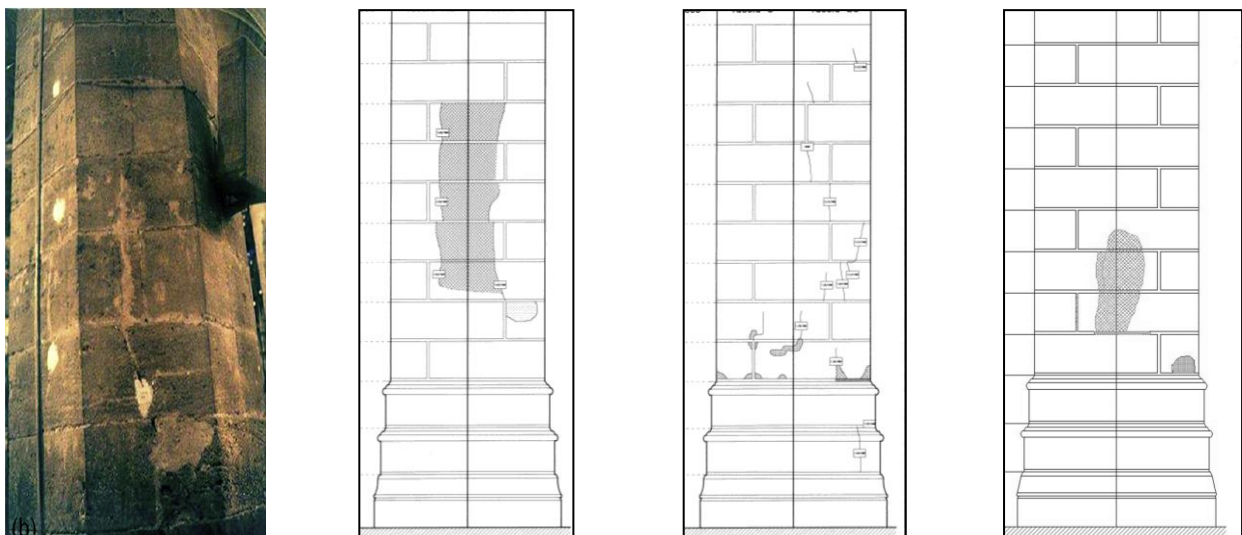
Cracking survey revealed that some of the structural elements of the cathedral have the following types of cracks (González et al., 2008; Roca, 2001; Roca et al., 2013; Abacilar, 2010). For columns, vertical or oblique cracks exist in some of the columns and tend to concentrate close to the less confined parts of the section, i.e., the corners, Figure 8. In some cases, the cracks cross several rows and shape full wedges partially or totally detached from the core of the column. For vaults, two types of cracks

Figure 8. Cracking in columns: a cracked wedge near to the column corner (most left); and documentation of the cracked faces (three drawings).

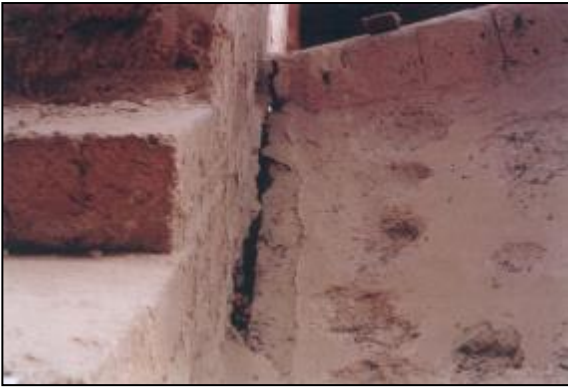
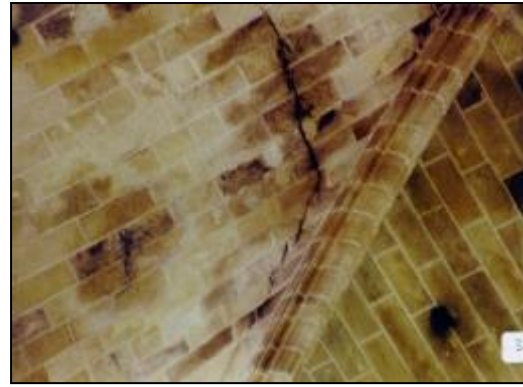
can be found, Figure 9. The first are the separation crack along the contact line between a vault of the central nave and the supporting transverse arch. The second are cracks inside the vault masonry. For walls, cracks in clerestory walls are mostly developed along the mortar joints. Some of these cracks are related to the out-of-plumbing experienced by the west façade, even after the reconstruction previously discussed. For other structural elements, cracks also exist such as in the buttresses and lateral nave vaults.

Figure 9. Separation between a vault and supporting arch (left); developed crack in a vault (right).

- Cracks exist in almost all the structural elements of the cathedral including the columns, the vaults and the clerestory walls. The static monitoring revealed that the crack existing between the sixth vault and the supporting arch is the one with the highest progress rate of about 10mm/century.

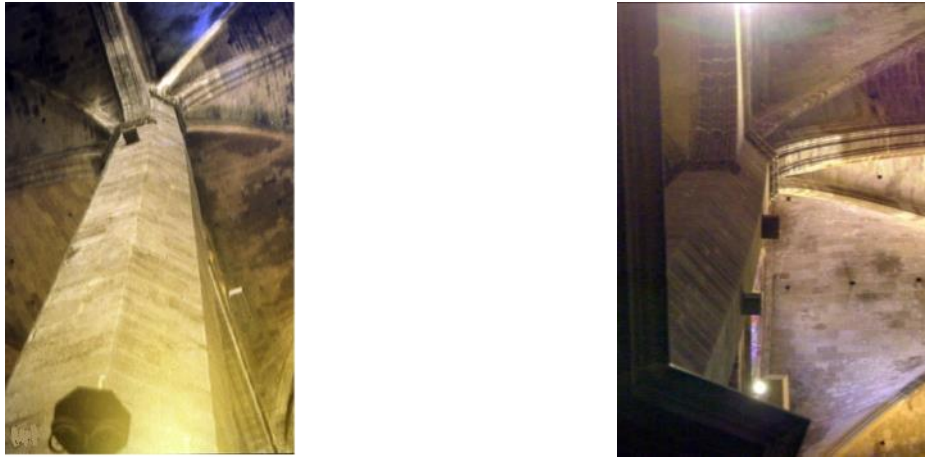
A complete survey of the deformations of the cathedral was carried out by González and Roca (2003-2008). It was found that the deformations of the overall structure are perceptible. The columns show significant lateral deformations, Figure 10. In some cases, it reaches up to 30 cm, near to 1/100 of the height at the springing of the lateral vaults. Moreover, all the bays of the cathedral are showing clear deformations. In Figure 11, the deformed shape of each of the seven bays of the cathedral is shown and the values of the measured deformations at some selected key points are reported for each bay. Those points are the keys and the springing of the central and the lateral arches and the top of columns. It can be noticed that both the magnitude and the direction of the deformation vary significantly and show almost random trend among the different bays. Maximum lateral displacement in columns ranges from 2 cm up to, in a single case, 26 cm, with an average of 13 cm corresponding to a ratio of 1/175 with respect to the height and 1/137 with respect to the free span (Roca et al., 2013; González et al., 2008).

The construction process can be considered the main reason for such deformation. It has been possible to identify the process leading to the complete construction of the fourth bay as shown in Figure 12 (Domenge, 1997). It started with the lateral chapels, followed by the columns, then one lateral vault, then the other and finally the central one. It can be observed that during a period of about 5 years (from 1453 to 1458), the lateral vaults were already pushing against the columns while the central vault was not yet there to counteract their thrust. The lateral vaults were built before the construction of the central ones. In this case, historical research has not provided, so far, any hint on the way the structures were stabilized while the central vault was not yet built (Figure 12 (c)). Bourgeois (2013) and Pela et al. (2014) showed that they could have been stabilized by means of auxiliary devices, in specific, iron ties

Figure 10. Deformed columns: internal column (left); and column at triumphal arch (right).

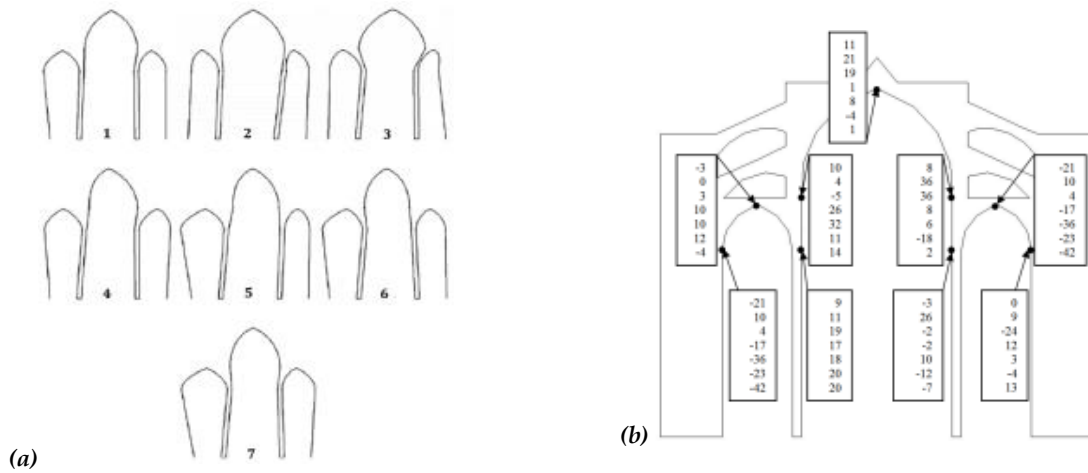
Figure 11. Deformation survey: (a) bays' deformed shapes (numbering from east to west); and (b) values of deformations (cm) at each of the seven bays in the same order of (a) (from Clemente, 2006).

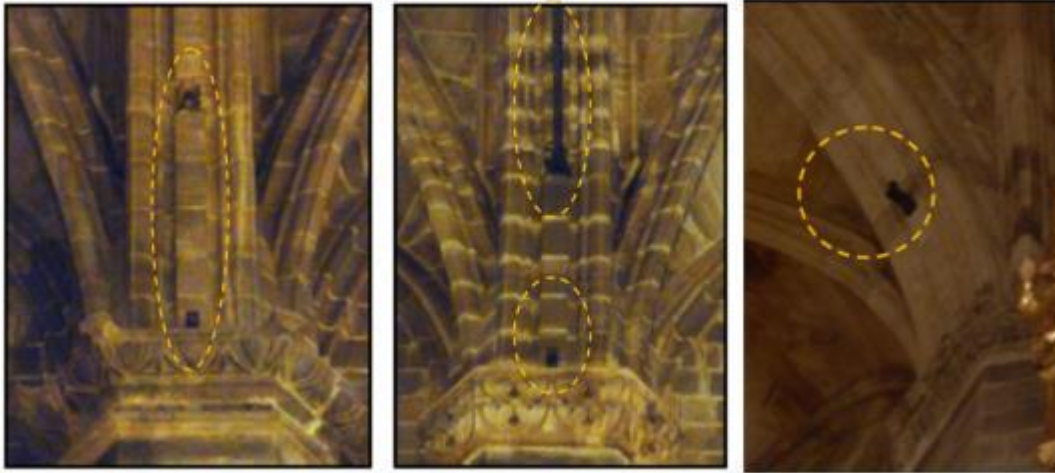
across the lateral arches and struts across the central one (Figure 13).

Figure 13. Evidences of using of ties in Mallorca cathedral construction: northern nave of 7th bay (left); northern nave of 6th bay (center); and southern nave of 4th bay (right) (Bourgeois, 2013).

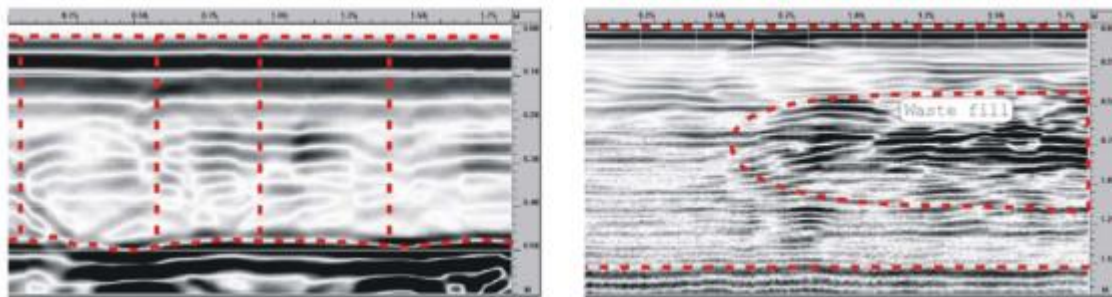
For walls, the obtained radargrams showed that they were composed of a single 45cm layer of stone masonry with no inner filling, Figure 14 (left). There was no important reflector inside the block stones meaning that no significant internal cracks affect the walls. For buttresses, it was found that they were constructed using one external stone masonry leaf about 35cm wide at both sides with an internal layer of a poorer stone block masonry, Figure 14 (right). A single core perforated in a buttress showed that the inner material consists of blocks of a poor and easy workable type of local limestone. For columns, GPR images indicated that they were built with five stone blocks, four external stones and one internal block (Figure 15). No important anomalies associated to voids or important internal cracks were found. Three of the cracked columns were selected for inspection using seismic tomography. The seismic tomography images confirmed the results of the GPR that the columns have an inner sector built with a stone similar to the outer limestone ashlars and no voids or filling materials exist. The tomography images showed good quality unions between block stones using low quantity of mortar.

Figure 14. GPR inspection: radargram of clerestory wall with red lines showing possible distribution of stones (left); and radargram of a buttress with inner filling surrounded by a red closed shape (right) (Roca et al., 2008).

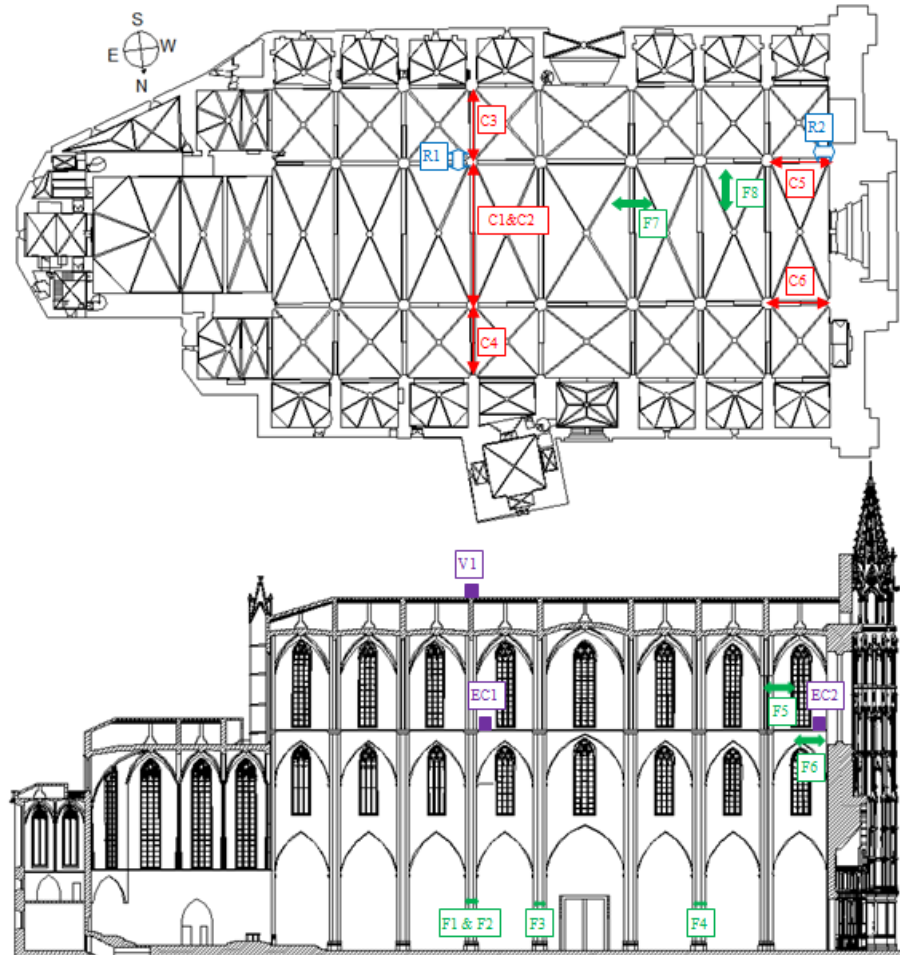
A static monitoring system was installed in the cathedral for a period of about five years from 2003 to 2008. The system aimed at measuring the cracks widths, the tilts and the convergences at some critical positions in the cathedral, in addition to measuring the environmental actions of the temperature, the humidity and the wind. In Figure 24 the complete system is shown. As seen, the cracks were monitored at three columns (F1 to F4), two locations at the upper south clerestory wall (F5 and F6) and two vaults (F7 and F8). The convergences were monitored at six positions (C1 to C6), two of them (C5 and C6) gave indication of the movement of the west facade.

midity were monitored at two positions (EC1 and EC2) and the wind was monitored at the position V1. It was concluded that the crack with the highest opening rate was the one between the sixth vault and the supporting arch (F7) that had a trend of about 10 mm/century. This showed that the west

façade perhaps was still tilting out-of-plane. The cumulative trends of the convergences were not considered alarming. It was also observed that both of the cracks and the convergences tended to increase with the temperature raising and decrease with the temperature lowering.

Figure 24. The static monitoring system of Mallorca cathedral (González and Roca, 2003-2008).
