DOI: 10.5281/zenodo.4107167

# PHYSICAL ANALYSIS AND TREATMENT OF DISINTEGRATED ISLAMIC MURAL PAINTINGS FROM THE 15<sup>th</sup> CENTURY TAQI ALDIN ALBISTAMI HOSPICE

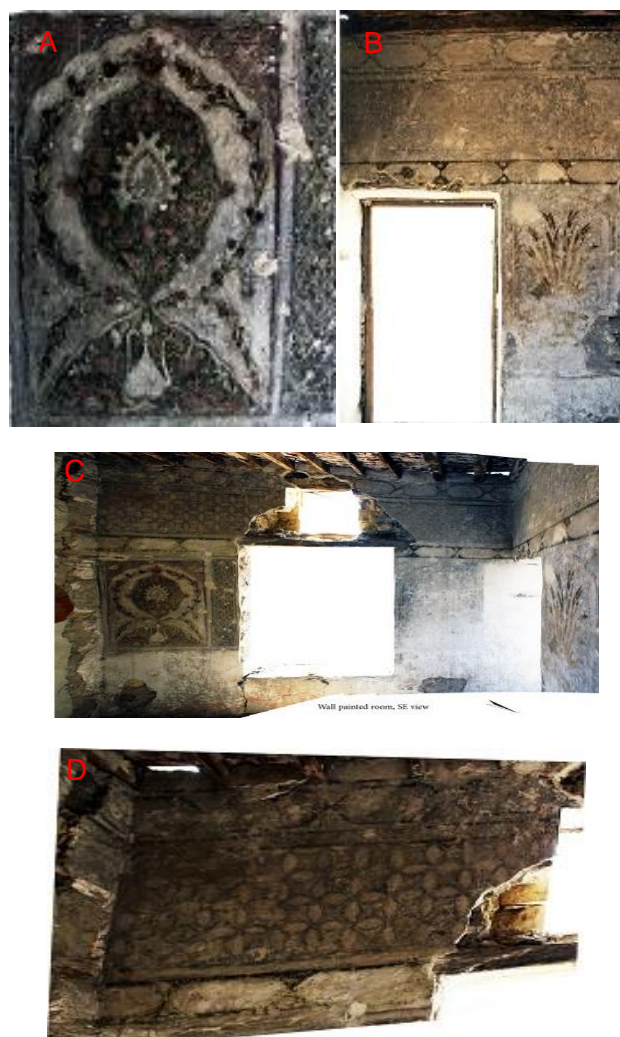
Figure 1. a) The mural paintings calling the Mehrab (Niche) and the enlightened heart At Takiya Of Taqi Al-Din Al-Bistami, b) the mural paintings containing Geometric motifs, and Floral Ornaments, c) all the mural paintings and the condition assessment of the mural paintings, d) The deterioration factors facing the mural paintings.

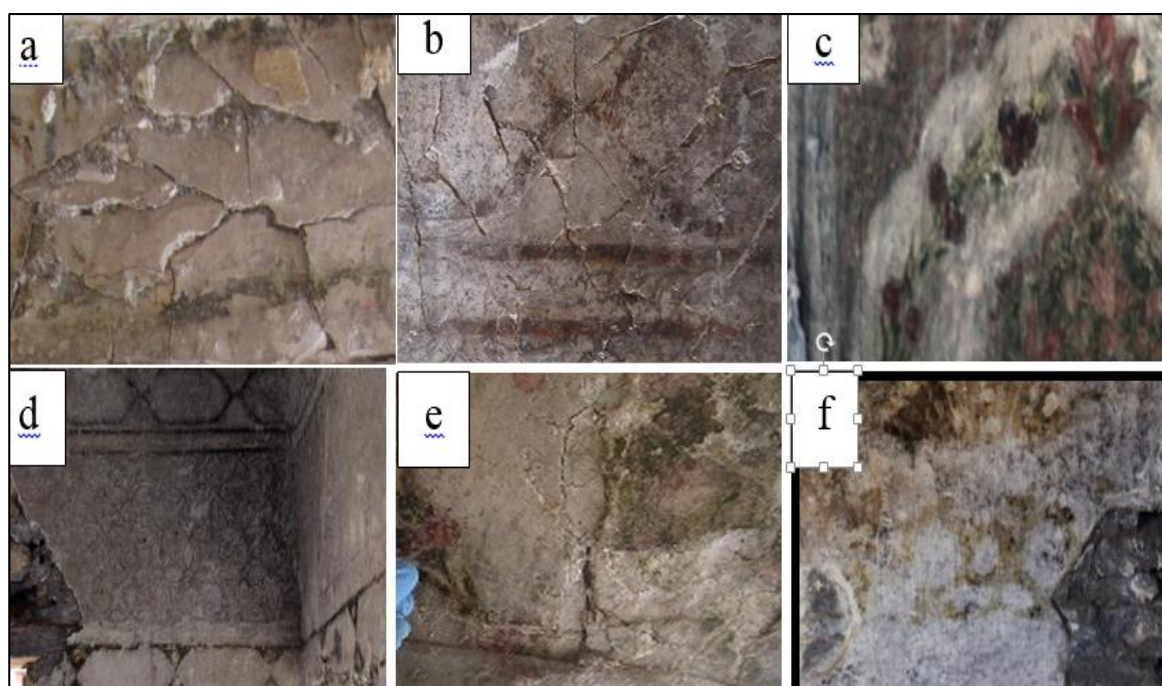
Figure 2 (a,b,c,d,e,f). Details of deterioration of the mural paintings (cracks, change in colour, missing parts, flaking, and lost in the preparation layers).

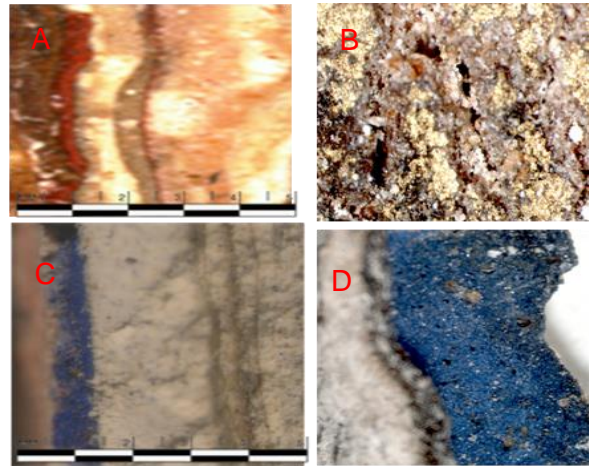
Figure 3. Stratigraphic structure of the painted ground layers (red & blue) by the stereomicroscope. (A) red pigment, under the reflected light and shows over painting (support- coarse ground layer, paint layer, dust- fine ground layer- red colour dust). (B) Shows of the Flacks, loss in the red colour. (C) A cross section of the blue colour showing six layers (support- coarse ground layer, dark preparation layer, fine ground layer, dark preparation layer, fine ground layer blue colour). (D) Cracks and burrs in the blue colour.

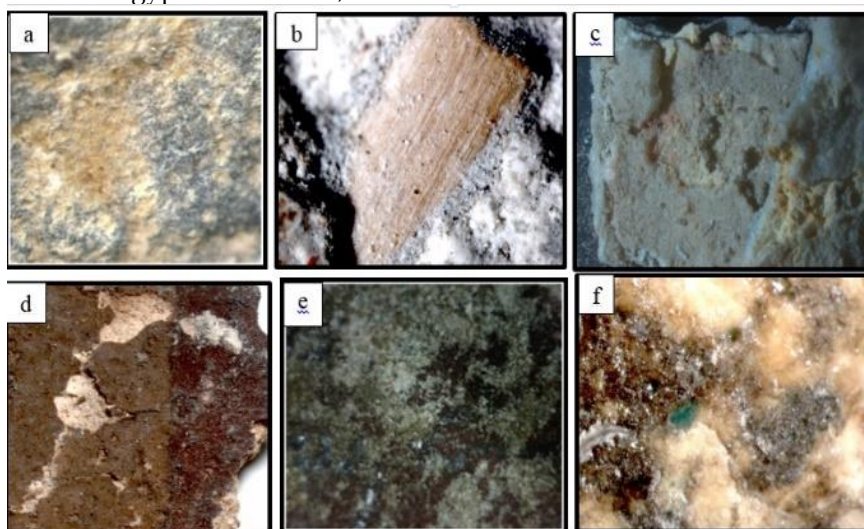
Figure 4. Imaging by the stereomicroscope (deterioration of Colours): (a) Black colour deterioration 150x, (b) The appearance of plant additions at the under of the colour layer 160x, (c) The crystallization of salts on the painted surfaces 150x, (d) Detachment in some layers of yellow colour 100x, (e, f) Degradation of red pigment and mixing with green colour 190x.

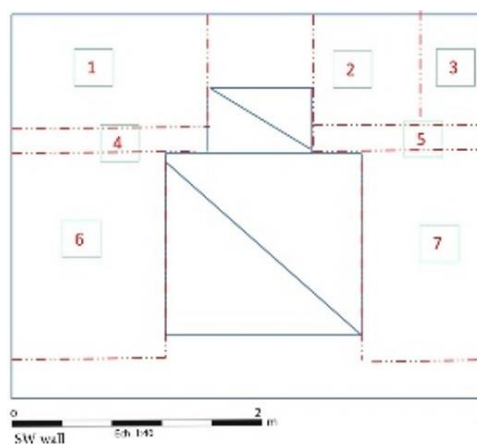
Figure 9. A drawing showing the cutting points in the eastern wall before detachment.
