UNLOCKING THE FUTURE OF YORK'S HISTORIC BUILDINGS: SUSTAINABLE STRATEGIES AND INNOVATIVE CONSERVATION DECISION MAKING

Ashley Lingle*, Louise Cooke, Lara Daniali, Michael Dobbs, Dav Smith

University of York, Department of Archaeology, UK

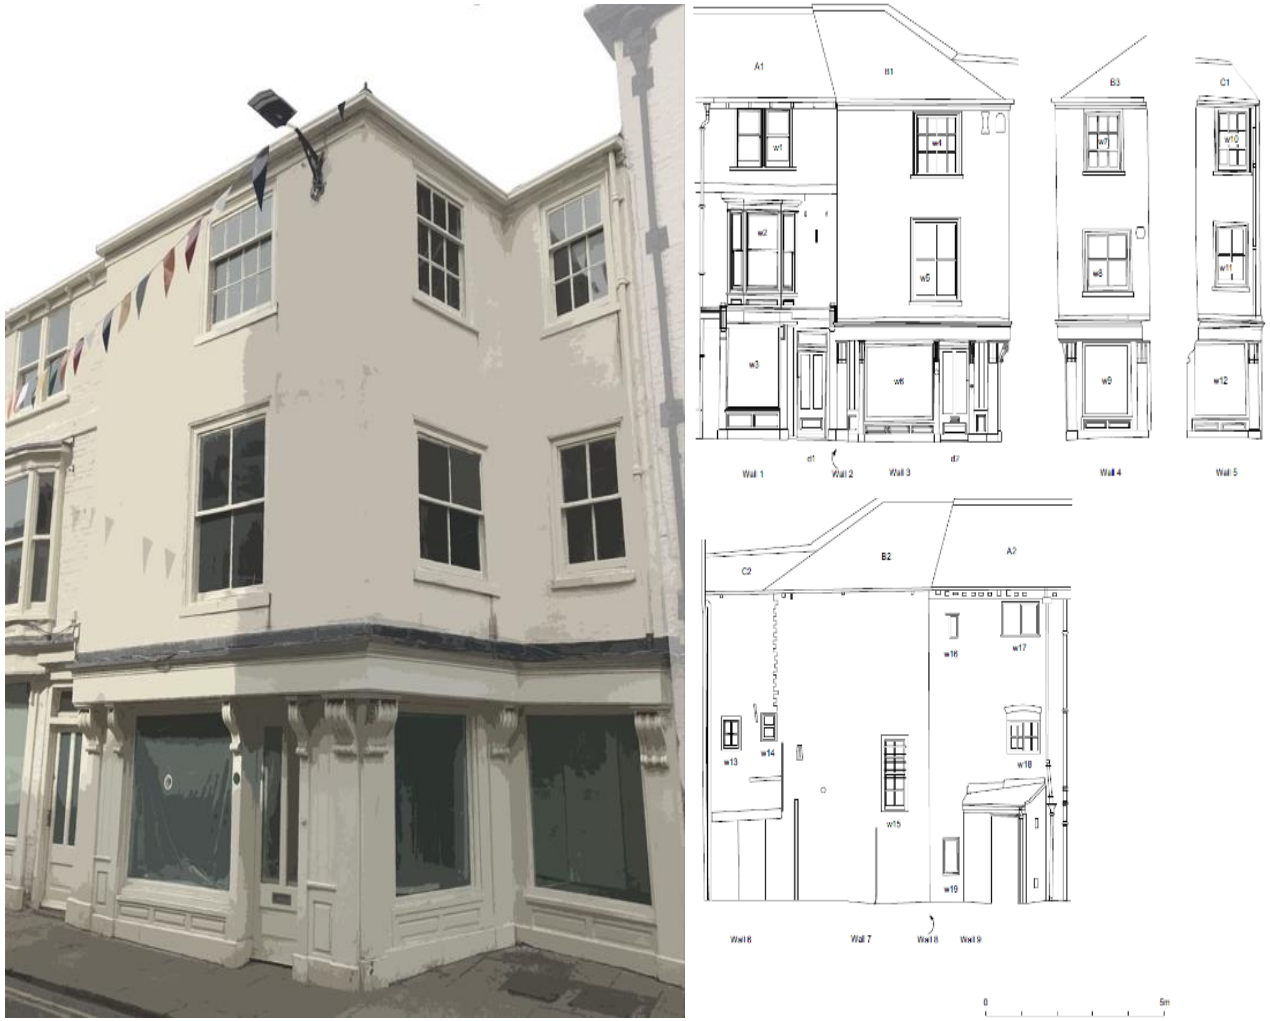
Figure 1. 60 Goodramgate, York. Left: Property in May 2023. Right: Front and back elevations (© 2020 Maybank Buildings Conservation, adapted with permission).

60 Goodramgate exemplifies a rich intersection of history and architecture, originating from two distinct structures deeply rooted in York's heritage (Figure 1). This building serves as an ideal case study for this research due to its architectural complexity and historical significance. The origins of the building are contested, by some accounts the building stands as part of the earliest surviving examples of timber-frame jettying in the UK, though this association may have been incorrectly attributed (Smith, 2021). Portions of 60 Goodramgate were rebuilt in the late 18th century, with further modifications occurring in the 19th and 20th centuries, reflecting York's capacity for adaptation and resilience. Currently, the structure is a combination of timber-framing and brickwork, with rendered facades, and a dual roofing system of tile and slate. Notably, the chimney stacks have been removed (Figure 2).

This study builds upon the recent exterior restoration work, specifically the lime rendering, as shown in Figure 1. The data presented here comprises approximately one year of research, aimed at informing further decisions regarding building adaptations.

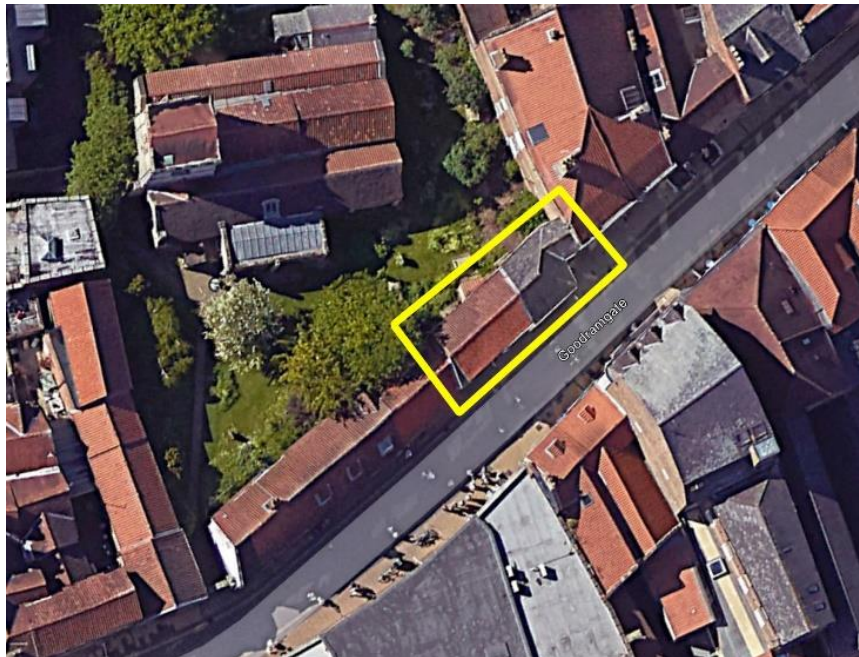
Figure 2. Aerial view of 60 Goodramgate with the tile (left) and slate (right) roofing systems.

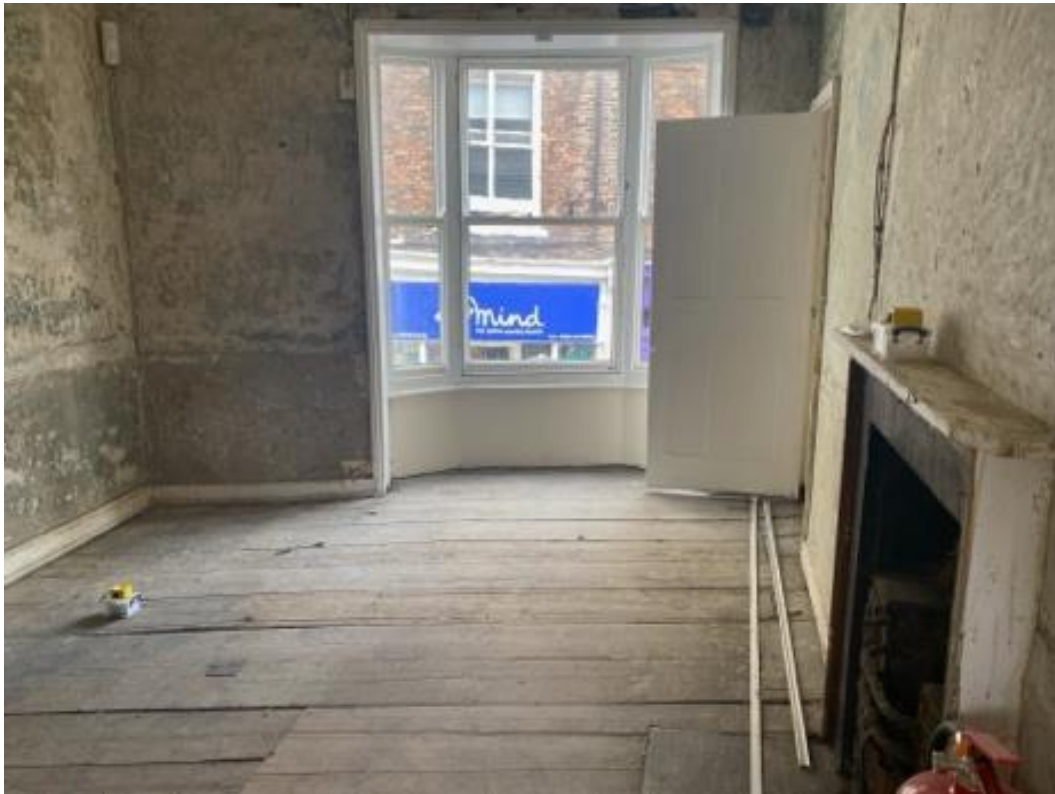
Figure 4. Location of logger BLF1 (left) and logger BLF2 (right).

therefore, does not completely accurately reflect the ambient conditions of the room in question. For example, BLF1 is positioned near a bay window and receives direct sunlight on sunny days, consequently recording very high temperatures and low humidity (Figure 4). These oversized highs and lows are not present in BLF2, indicating that BLF1 does not accurately reflect the ambient temperature and humidity of the room. Similarly, the left ground floor window has a much more opaque covering than that of the right, meaning that the BLG2 received less sunlight than TFRG2. Logger accuracy can also influence the perceived significance of the outcomes of the data, so consideration is needed when reflecting on the outcomes. While the wider research of this project included the attic and underfloor space of the structure, these are excluded from this publication for clarity of discussion.

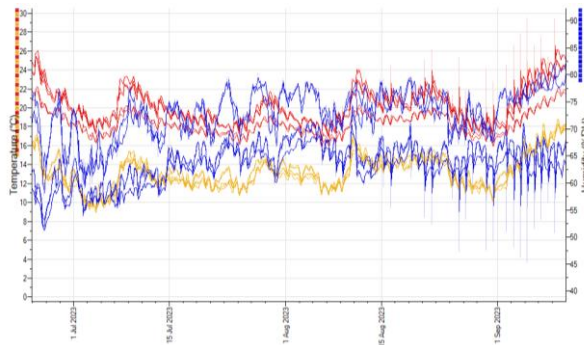
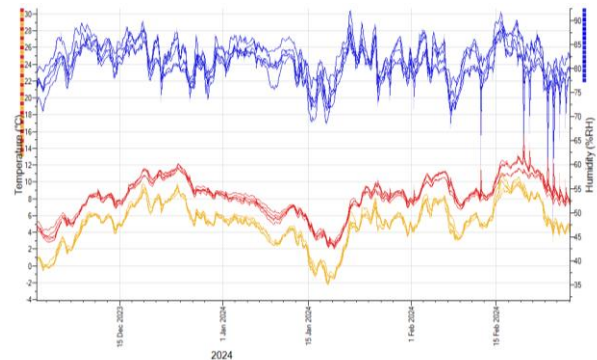
Figure 5. Environmental data graphs during the relevant study periods. Humidity noted in blue, temperature in red, and dewpoint in yellow. Note different scales are used for each graph for clarity.

Figure 5 shows the environmental conditions in winter and summer weather, indicating that the right and left structures perform similarly in both conditions. In summer months, the left brick structure performed slightly better than the right timber framed, though not to a highly significant degree in relation to overall human comfort. This variation was most evident on the ground floor, where TFRG2 showed

rose by more than 15°C throughout the afternoons, the indoor temperatures remained relatively unchanged within each of the main floor levels, fluctuating by only 1-2°C. The recordings were generally 4°C within each other, and the left structure was typically warmer than the right on the first and second floors. In winter conditions, the floor levels closest to the ground were warmer, but the indoor temperatures dropped to between 0-14°C.
