PLANT GROWTH AFFECTING MASONRY STONE BUILDING IN RAMESSES II TEMPLE, KARNAK, EGYPT

Ahmed Hosam Elden¹, Ahmed Sallam² and Mohamed El-Gohary*³

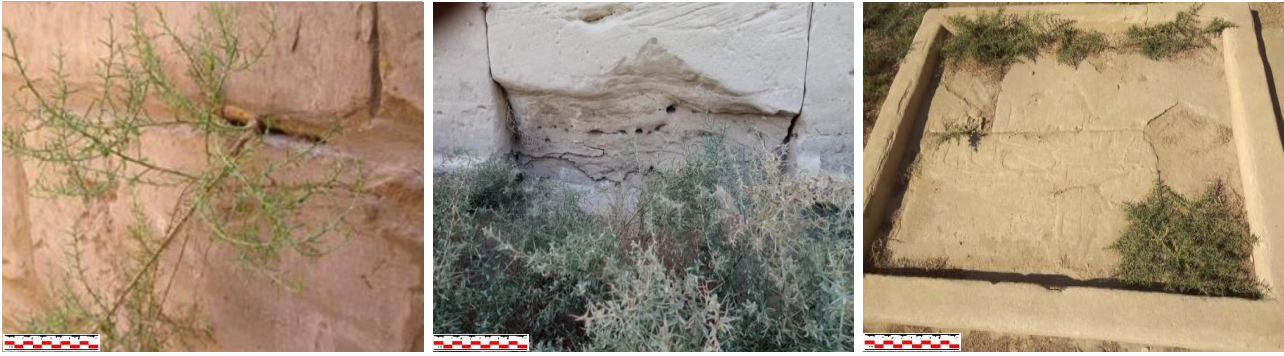
Microorganisms found in air, water, and soil can grow and live on inorganic and organic materials. Enzymes secreted by these species can be catalysts that attack building materials by chemical reactions (Betina, 1993). Relative humidity and temperature levels decide whether or not these species survive (Elgohary et al. 2022). From a specialized view, it could be claimed that some harmful effects are caused by some fungi and bacteria due to *Phragmites* and *Imperata* on the temple Ramses II stone. Some features are shown in Fig.2.

Figure 2. Shows growing higher plants in different area of the temple causes some deterioration features

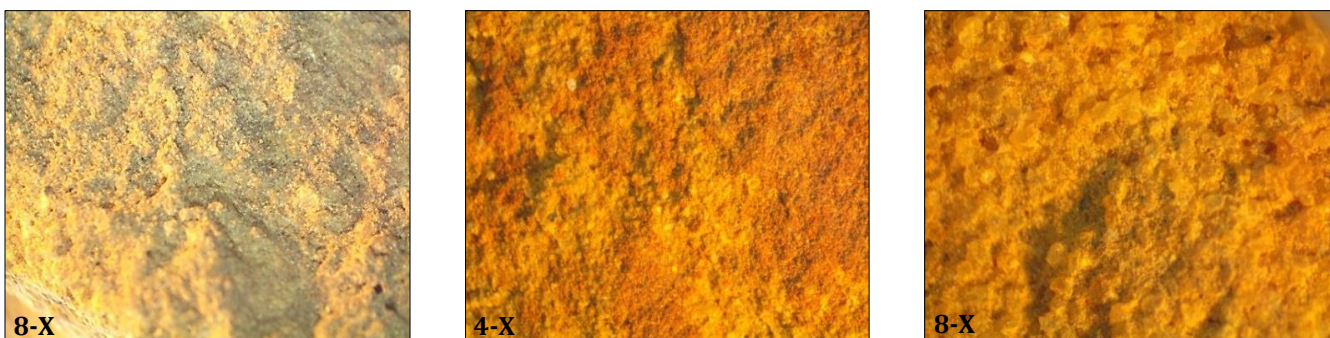
The Optika microscope was used to determine the change in sandstone samples, as shown in Fig. (3). The photos of different samples showed silica grains, dirt, dust, decomposition of quartz grains, changing the surface color of sandstone, and corrosive of cement materials due to deterioration processes. They also showed the reddish-brown color as an indication of iron oxide (hematite) and the weakness of the binding material.

Figure 3. Sandstone samples under stereo microscope

Stereo microscope results, figure (3) illustrated that the *dirt and dust deposition* as an important alteration form (Anaf et al., 2015) affected the temple stone surfaces, causing a visual nuisance, especially in decorated areas (Grau-Bové and Strlič, 2013). *The decomposition of quartz grains*, figure (3-a), resulted from alteration processes owing to the synergetic environmental factors characterizing the study area, especially “plant enzymes, groundwater, sunlight, and wind” (El-Gohary, 2017; Hosam, 2021). *Changing the stone rock fabric or color superficial weathering*, figure (3-b) was attributed to the effects of some chemical reaction between sap roots of plant species and stone components that was enhanced with the high ratio of sunlight that led to oxidation of iron-bearing, as attested by Begonha (1994) and El-Gohary (2015) in similar cases. *Corrosive cement materials and loss of material below the stone surface*, figure. (3-c) resulted from the development of cracks and

the ongoing loss of cohesion between grains, attributed to the etchable of cement material, particularly with a salt mechanism within the pores and under the surfaces (Ahmad, 2012; Kottke, 2009; Ouacha et al., 2013; El-Gohary, 2015)

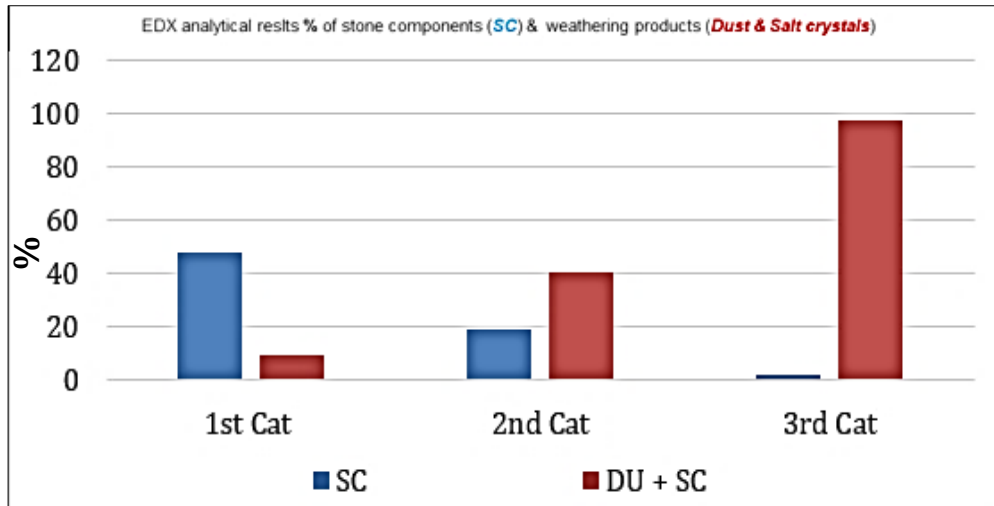
Figure 6. The relation between stone components and weathering products

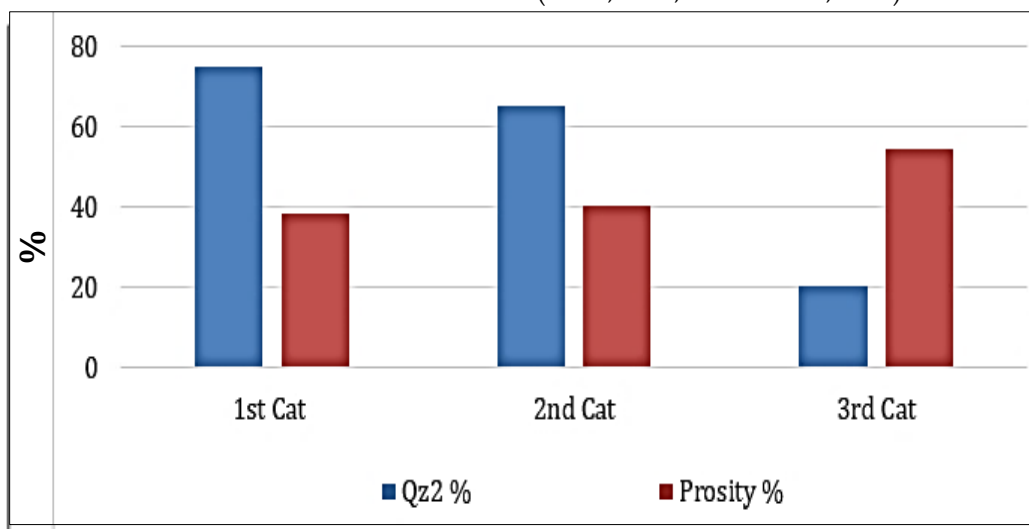
XRD assured the EDX results. Quartz (SiO_2), fersilicite (FeSi), and xifengite (Fe_5Si_3) are the major components of the 1st and 2nd cats., as shown in figure (5-a). Quartz grains (SiO_2) represent the main component in all investigated samples (75%, with a porosity index of 38.15%) in the 1st cat. and (65% with a porosity index of 40.30%) in the 2nd cat., figure (7). They are commonly clear, rarely cloudy and moderately to very well-sorted (Aggour, et al., 2012). It is characterized by bimodal, very well-sorted particle size and ferruginous cement (El-Gohary, 2013; El-Gohary, 2015), with the presence of interconnected pores and a relatively high permeability index (Zaid, et al., 2018). The 3rd cat. is a heavily affected sample, and quartz represents (~ 20%), with a porosity index of 54.21% and is characterized by degradation features

due to the aggressive effects of dominated salts present with large proportions in the study area. These salts (Halite, Sylvite, and Thenardite) were spread and transmitted from the soil to the stone through capillary rising (Hosam, 2021). Sylvite (KCl) is a potassium salt that occurs due to deliquescence-recrystallization/ rehydration of salt crystals under oscillating humidity due to its hygroscopic properties (Godts et al., 2017). Halite (NaCl) and Potassium Nitrate (KNO_3) are soluble components of type I pore solutions. They are often found as a salt efflorescence in the damaged zone of areas affected by rising damp, as agreed with data presented by Steiger, et al. (2011). Furthermore, the presence of (Na_2SO_4) known as Thenardite, causes some cracks and micro-fissures that play an important role in the stone bleeding phenomenon (El-Gohary et al., 2022) that ultimately destroys stone, especially with high crystallization pressure (Yuan, 2019; Wasserman, 2021).

Figure 7. Porosity index of the investigated samples in the 1st cat., 2nd cat. & 3rd cat.
