RE-USE PROPOSALS AND STRUCTURAL ANALYSIS OF HISTORICAL PALACES IN EGYPT: THE CASE OF BARON EMPAIN PALACE IN CAIRO

The Palace of Baron Empain in Cairo is a unique architectural masterpiece of its kind. Edward Empain, a rich Belgian, built it in 1911 influenced by the architecture of the famous Cambodian temple of Angkor Wat. The palace is composed of three floors (basement, ground and first) and a roof, it is surrounded by a garden from all sides. It suffered from neglect for decades, and recently appeared initiatives for its restoration and re-use. This paper aims to provide a proposal for the re-use of the palace. For this purpose, the palace was visually inspected and the signs of damage were documented and explained. A re-use proposal was developed in which the ground floor is re-used as a small museum after being furnished on the historical style. The first floor is re-used as a museum and/or a motel. The roof is re-used in holding cultural seminars, and as a place for distinctive imaging types. The palace garden is to be re-used similar to its historical usage as an open space for celebrations and parties. The basement is re-used as a service floor for the visitors. To suppor

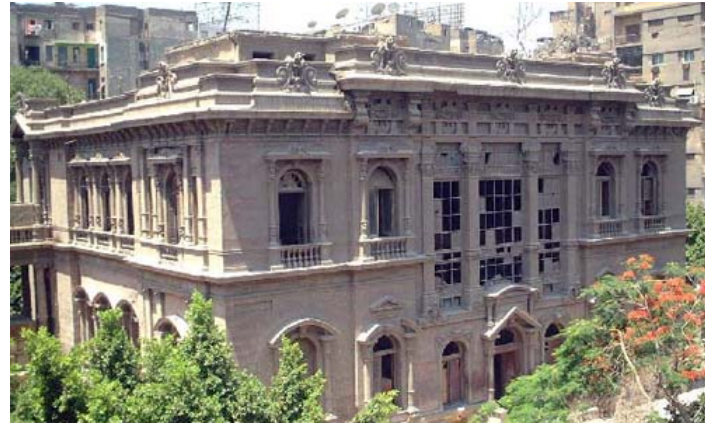
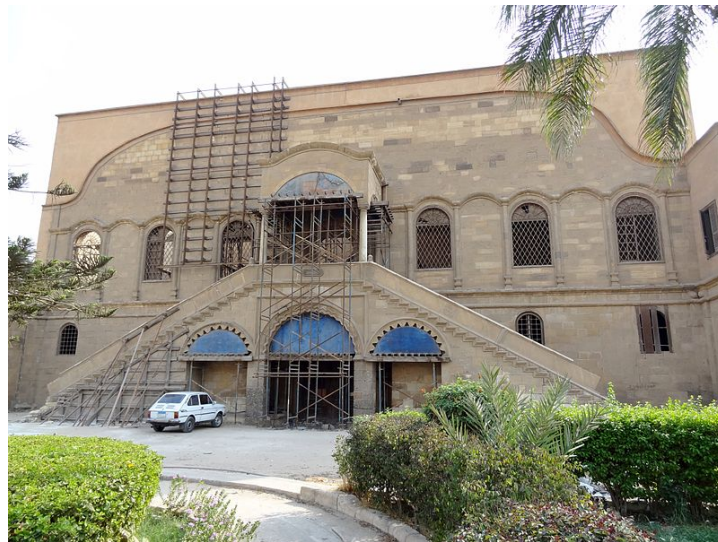
Figure 1. Examples for un-used Egyptian palaces suffering from neglect and deterioration: (a) Said Halim palace, (b) Al-Gawhara palace, and (c) Al-Sakakini palace.

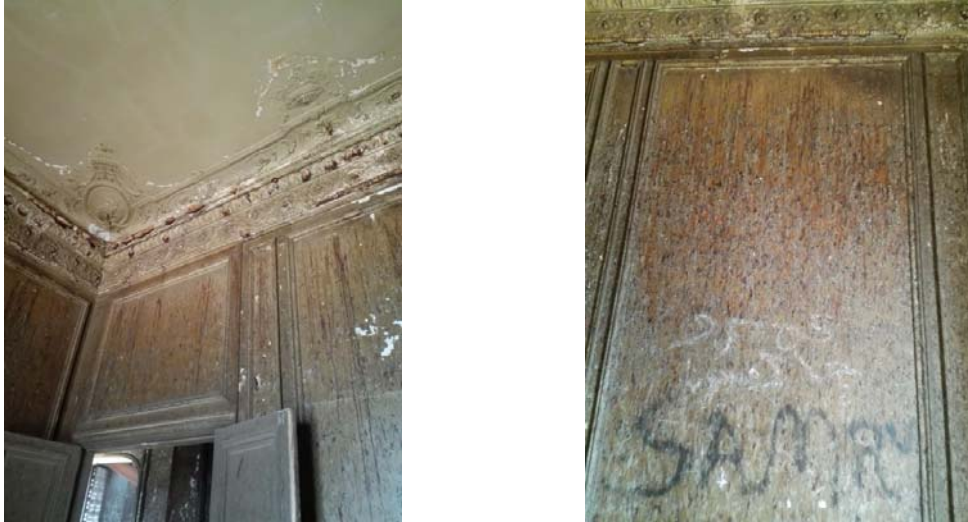
Figure 2. Two photos inside the room of blood in Baron Empain palace showing the stained walls with blood of, possibly, sacrificed animals during Satanism activities in 1997.

This paper gives a proposal for the re-use of one of the most famous palaces in Egypt; it is the Baron Empain palace in Heliopolis, Cairo. To support this proposal a detailed structural analysis of the palace was carried out. One of the reasons behind the fame of Baron Empain palace all over Egypt is the case of Satan worshippers in mid of 1997. More than 100 young Egyptians were arrested and caused of practicing Satanism (Abdel-Wahed, 1998). It was a public opinion case that attracted a lot of attention. The arrested people were practicing these activities in Baron Empain palace. One of their activities was scarifying animals, and till today, there is a room in the palace where all the walls are stained with blood, possibly of animals scarified during these activities. The room is known now as the room of blood, Figure 2.

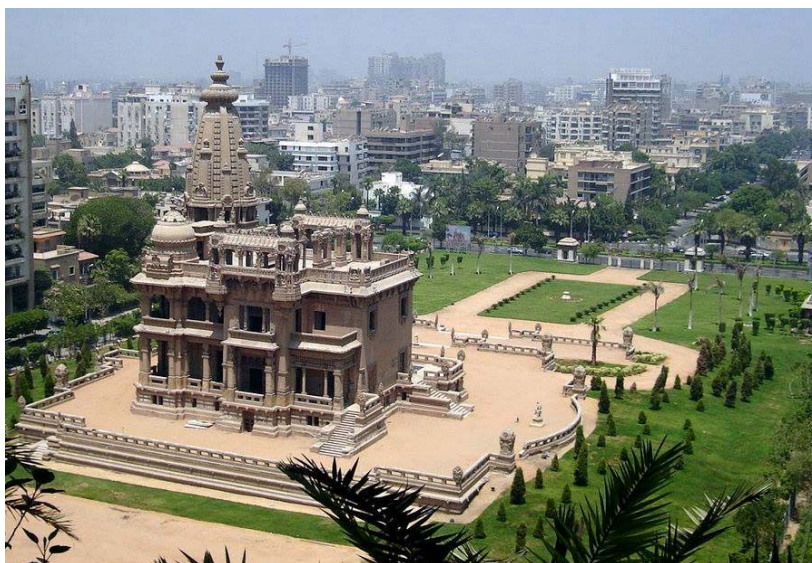
Figure 3. Global view of Baron Empain palace looking at the rear façade and the front and rear gardens.

The Baron Empain palace (Figure 3 and Figure 4) is located at Heliopolis district in Cairo. This district is at ten kilometers northeast of Cairo and is very near to Cairo international airport. Heliopolis was created from 1905 to 1913 by the Baron Empain and Boghos Nubar. They decided to create a new district built to European technical, functional and sanitary standards to be suitable for the bourgeois class lived in Egypt at that time (Mercedes Volait et al., 2003). The palace was constructed in 1911. It is composed of three floors and a roof. Additionally, it is surrounded by a large garden from all sides as can be seen in the layout in Figure 5.

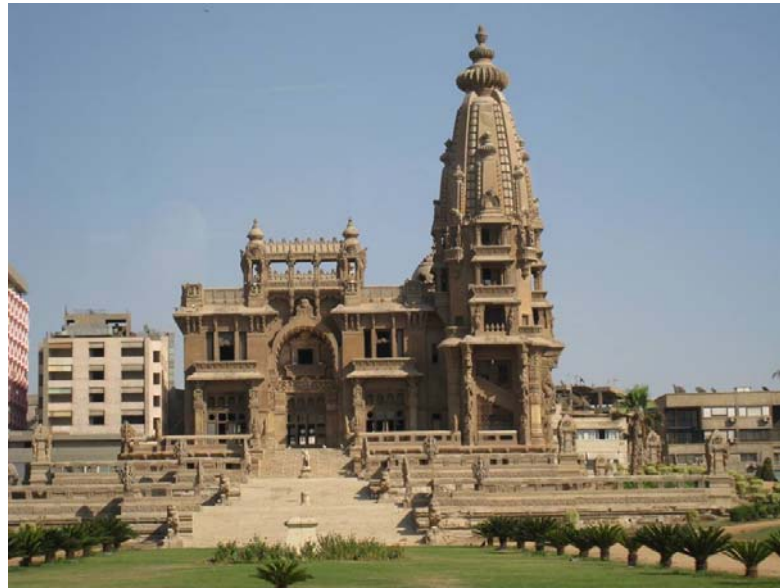
Figure 4. Global view of Baron Empain palace looking at the front façade.

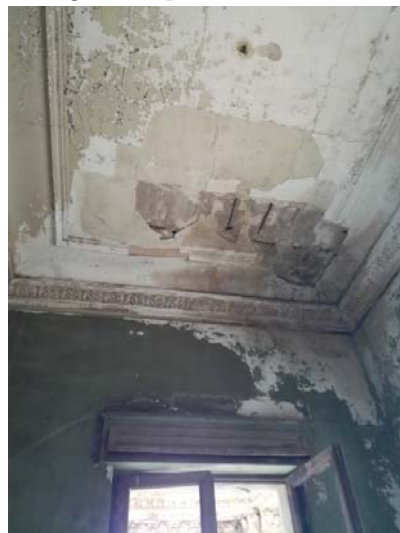
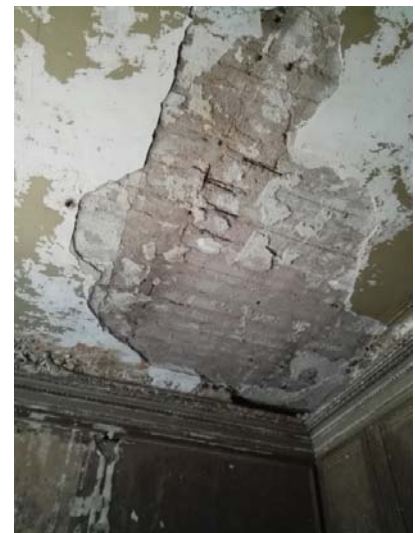
Figure 7. Falling down of the concrete cover of ceilings: (a) first floor ceiling damaged parts, (b) and (c) samples from damage, (d) basement floor ceiling damaged parts, (e) and (f) samples from damage.

The only obvious noticed damage was the falling down of the concrete cover of some parts of the ceilings of the basement and the first floors, Figure 7. No such damage was observed in the ground floor ceiling. For the first floor ceiling, the infiltrated rain water may be the reason of such damage. The parts of

the basement floor ceiling that are suffering from such damage are these parts of the stairs connecting the palace with the garden. Those parts are directly exposed to rain water and this may be the reason of the falling down of the concrete cover.

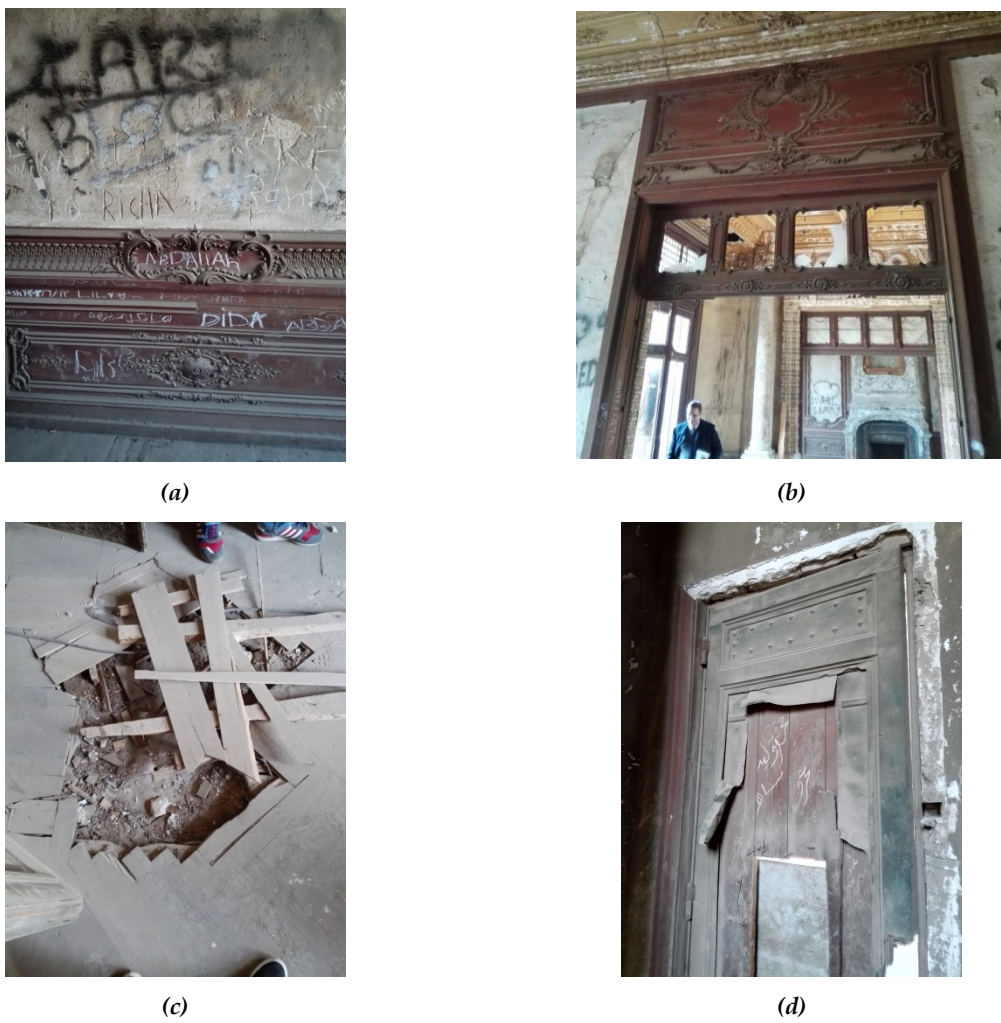
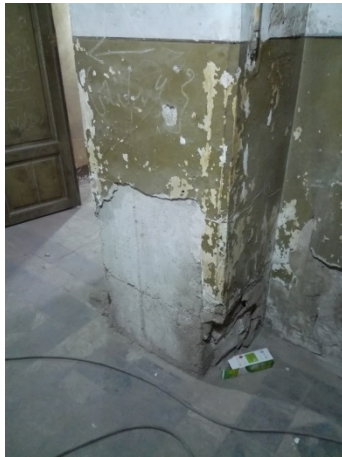
Figure 8. Non-structural damage: (a) anthropogenic actions, (b) broken glass of doors, (c) deteriorated wooden floor's finishing, (d) deteriorated door, (e) falling plaster and (f) deteriorated roof flooring.

Other non-structural damage was observed. This included the harmful anthropogenic actions by writing on the walls using sprays which distorts them (Figure 8-a), broken glass of doors and windows (Figure 8-b), deterioration of the wooden finishing of floors (Figure 8-c), deterioration of doors (Figure 8-d), falling of plaster (Figure 8-e) and deterioration and missed parts of the roof flooring (Figure 8-f).
