MONITORING BUILDING MATERIALS EXPOSED TO MARINE ENVIRONMENT: EXAMPLES FROM FARASAN ISLANDS, SAUDI ARABIA

Abubakr Moussa

Department of Conservation, Faculty of Archaeology, Cairo University, 12611 Orman, Giza, Egypt

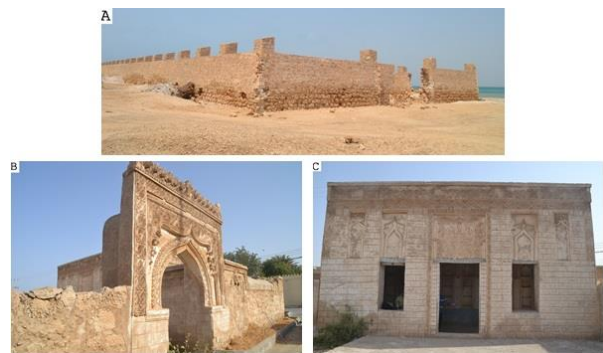
Figure 2. A: The house of German. B: Ahmed Al-Refaie house. C: Hussein Al-Refaie house

The studied heritage houses from Farasan islands are: The Hussein Al-Refaie house: 1912, the Ahmed Al-Refaie house: 1922, and The house of German: 1901 (Fig. 2); the first two houses were built by pearl merchants carrying the same names, the houses are located in the biggest one of Farasan islands which named "Farasan Al-Kabir". Architecturally the two houses are following the ottoman style, with some richness in decorations, ornaments are carried out using imported raw materials; as the local environment is very poor towards wood and masonry. The third house "German house" or "Germal house" according to the local dialect; is located in Qummah island which is about 8km from Farasan Al-Kabir,

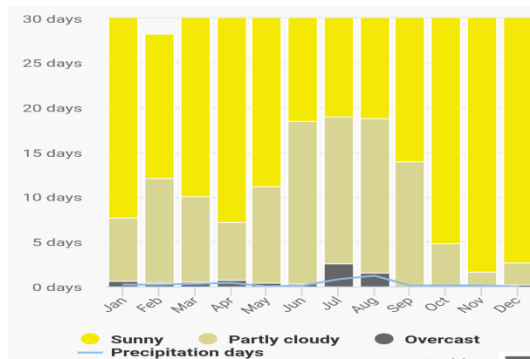
Figure 3. Climate graph shows the cloudy, sunny and precipitation days upon Farasan Islands (www.meteoblue.com)

Based on the data obtained from the Saudi meteorological agency and climate experts; in addition to the data obtained from the specialized websites, it is concluded that precipitation on Farasan islands is very rare in, the minor amount of rainfall ranges between zero and 2 mm per month, this can be registered in most months of the year while the maximum precipitation amount ranges from 5 to 10 mm per month, the rainy months are four: June, July, August and September, some seasonal rains can cause floods (Fig.3).

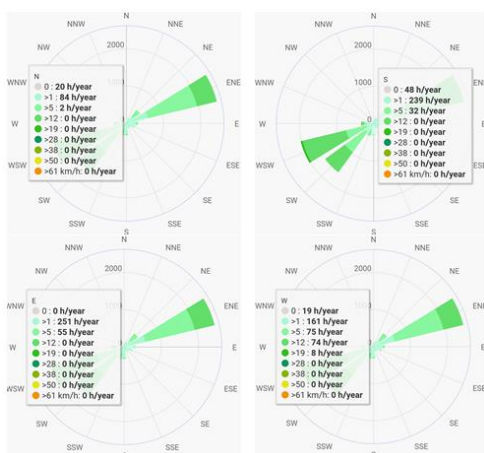
Figure 4. Wind roses showing the direction and speed of wind on Farasan Islands (www.meteoblue.com)

The combined effect of wind and precipitation determines the specific forms of wetting, washing out or the dangerous impact of hail on exposed surfaces, the primary source of humidity and salts on external walls especially in islands are wind and sea spray, south western wind on Farasan islands is the dominant, it blows for approximately 1300 hours per year with a speed average from 5 to 12 km per hour (Fig. 4).

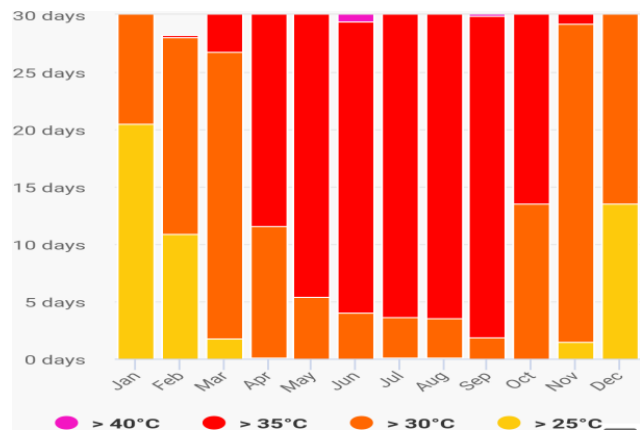
Figure 5. Climate graph shows the average temperature upon Farasan Islands (www.meteoblue.com)

Concerning heat; Farasan islands are registering high temperature year-round, temperature is often around 30 °C and 35 °C, but it goes higher than 40 °C in summer months (Fig. 5).

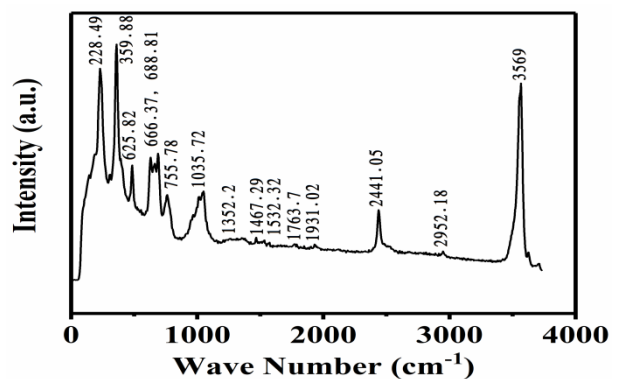
Figure 18. Raman spectrum of the first bedrock sample from Farasan islands

Further analysis for the bedrock samples has been carried out by mean of Raman spectroscopy; the first sample has shown the wavenumbers of C-C bands at 200-400 cm^{-1} and at 630-1250 cm^{-1} , the sample also shows Xmetal-O band at 150-430 cm^{-1} , while Si-O-Si, Si-O-C, and C=S bands appeared in the samples at 1020-1225 cm^{-1} , and OH bands appeared at 2880-3530 cm^{-1} (Fig. 18).

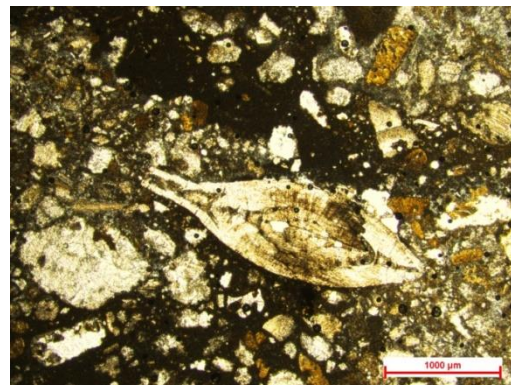
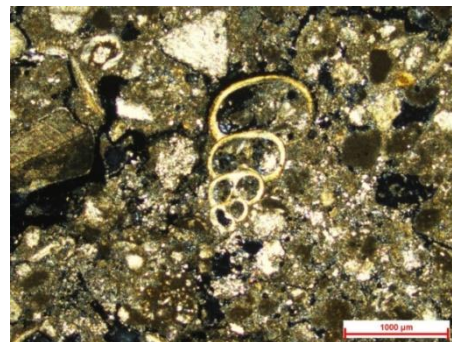
Figure 43. Photomicrograph of the first limestone sample from the house of German

Figure 44. Photomicrograph of the second limestone sample from the house of German

Figure 45. Photomicrograph of the third limestone sample from the house of German

Figures 46. Photomicrograph of the studied mortar sample from the house of German

Petrographic examinations of ancient stones allow us to determine specific minerals and rock textures, coarseness, and the relative or quantitative percentage of various constituents (Reedy, 1994). The petrographic and chemical study of the mortars gives information on the stone used to make it, on the technology used in the manufacturing phases (presence of lumps, charcoal, additives, etc.) and in the burning (Pecchioni et al., 2006). Petrographically, four samples from the German house were studied. The first and second samples were derived from the limestone blocks exposed to weathering. Wackestone is the most common type consisting the limestone blocks of the German house; both samples contain a ground mass of micrite (chalky limestone); the first contains fragments of algae, while the second sample contains fragments of shells (foraminiferal shells). Third sample was derived from the internal side of the walls, the sample is fossiliferous biomicrite or dolomitic skeletal packstone, and it contains brownish glauconite and nimolites. The fourth sample is a mortar sample; the petrographic analysis of the sample showed some common characteristics of mortars with respect to the matrix, which is mainly composed of lime with different types of aggregates. The main aggregate used in the mortars was sand, it can be also observed that the mortar is made of pure lime, originated from burning-slaking process, limestone (dolomite) pebbles and fragments are clearly visible together with few sub-rounded and rounded quartz grains of variable dimensions, fragments of algae, some shell fragments of gastropods and foraminifera were detected. The microphotographs of the petrographic examinations carried out on thin-sections prepared on stone and mortar samples are given in Fig.43 to Fig.46 inclusive.

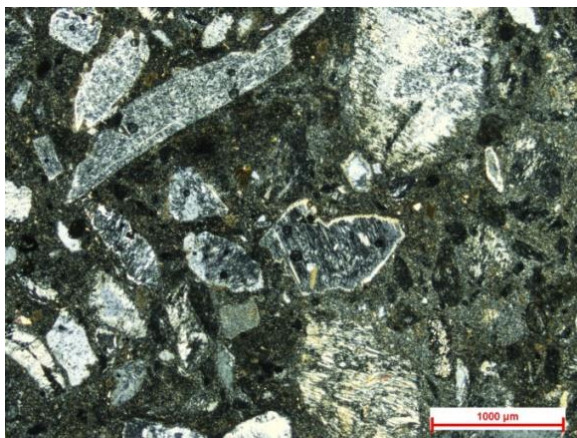
Figures 47. Photomicrograph of the studied limestone sample from Ahmed Al-Refaie house

Figures 48. Photomicrograph of the studied mortar sample from Ahmed Al-Refaie house

Petrographically; limestone in this house is algal limestone or skeletal packstone containing pellets of chalk and algal biomicrite, the skeletal particles are mainly represented by benthonic and minor planktonic foraminiferal tests in addition to some algal fragments (Fig. 47), the result of the XRD analysis (Figs 12&13) supports the mineral composition of the rock that revealed from the thin section investigation. Concerning mortar (figure 48); the investigation showed very few fine quartz grains, traces of gypsum particles and dolomite rhombs could be observed in some parts of the sample. Some additives of crushed igneous volcanic rocks (mainly basaltic rocks) are observed in the sample; these volcanic rocks are common in the red sea islands and are covered sometimes with coral reefs. It can be said that these dark coloured additives of feldspars phenocrystals are trial for giving some hydraulic properties into the mortar "a local trial for volcanic ash or pozzolanic additives".

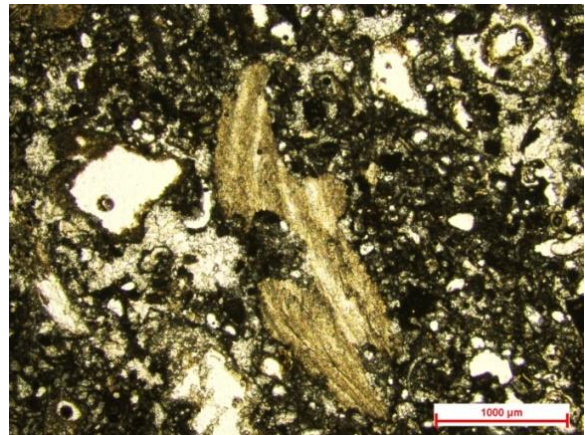
Figures 49. Photomicrograph of the studied limestone sample from Hussein Al-Refaie house

Figures 50. Photomicrograph of the studied mortar sample from Hussein Al-Refaie house

Petrographically; limestone in this house (Fig. 49) is a sandy limestone containing some intraclasts of carbonate rock fragments or feldspathic rock fragments, and pelecypoda shell fragments imbedded in dolomitic micrite which partially recrystallized into microsparry calcite. The stone has numerous pores, shrinkage microcracks and microvoids. Some voids are shown with partially filling of zoned idiomorphic ferron dolomite or ankerite rhombs. Mortar sample has shown the same results previously shown in Ahmed Al-Refaie house mortar sample in addition to over growth of calcium carbonate crystals, which means that there are voids in the matrix or there was a precipitation from a dissolved calcium carbonate, the sample showed also some oolitic fossils (Fig. 50).

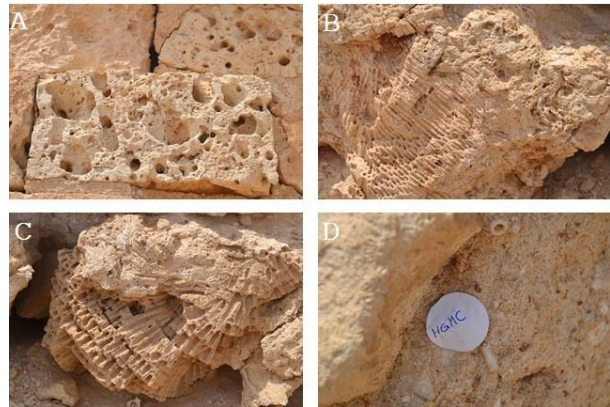
Figures 52. Four different shots from Farasan islands (German house) showing the effect of wind on building stones (A), the typical shape of coral building limestone (B,C) and the high amount of shells and fossils in plaster layer (D)

XRD, SEM-EDS and Raman spectroscopy of the bedrock samples made it clear that clay minerals, quartz and dolomite are contained in the mother rock, this represents more weakness and erodibility to the already degradable building materials derived from this bedrock, moreover; the chemical analysis by mean of XRF has shown that the loss on ignition ratio varies from 22% to 42.5%, what makes this amount such high is the nature of building materials which have a significant amount of organic substrates (shells and fossils) in their physical composition, the maximum loss on ignition ratio was registered for coral reef building limestone, which acts a building material and as a source for other building materials, this loss stands basically for the organic materials found in the sample, or for the amount of calcium carbonate burnt during firing process of the sample, field investigation emphasises that the nature of building materials is the main deterioration factor affecting Farasan heritage houses (figure 52).
