# MULTIANALYTICAL TECHNIQUES OF AL-BĪMĀRISTĀN AL-MU'AYYIDI MURAL PAINTING AT HISTORIC CAIRO: CONTRIBUTION TO CONSERVATION AND RESTORATION

In the present study, rare Islamic mural painting of Al-Bimāristān Al-Mu'ayyidi (1418/1420 AD & 821/823 AH) at historic Cairo has been uncovered and studied. A number of analytical methods included hand-held digital optical microscope, polarized light microscope (PLM), field-emission scanning electron microscope with energy dispersive X-ray analyzer (FE-SEM/EDAX), X-ray diffraction analysis (XRD) and Fourier-transform infrared analysis (FTIR) were useful to characterize some painted fragments. The results allowed to differentiate the stone as bioclastic-type limestone and its mineralogical composition as calcite ( $\text{CaCO}_3$ ) and halite ( $\text{NaCl}$ ). The render layer was made of calcite with few amounts of quartz ( $\text{SiO}_2$ ). Individual pigment minerals such as lazurite 'Lapis Lazuli' ( $(\text{Na, Ca})_8(\text{AlSiO}_4)_6(\text{SO}_4, \text{S, Cl})_2$ ) for the blue color and red lead 'Minium' ( $\text{Pb}_3\text{O}_4$ ) for the orange-red color, were identified. A mixture combined azurite ( $\text{Cu}_3(\text{CO}_3)_2(\text{O

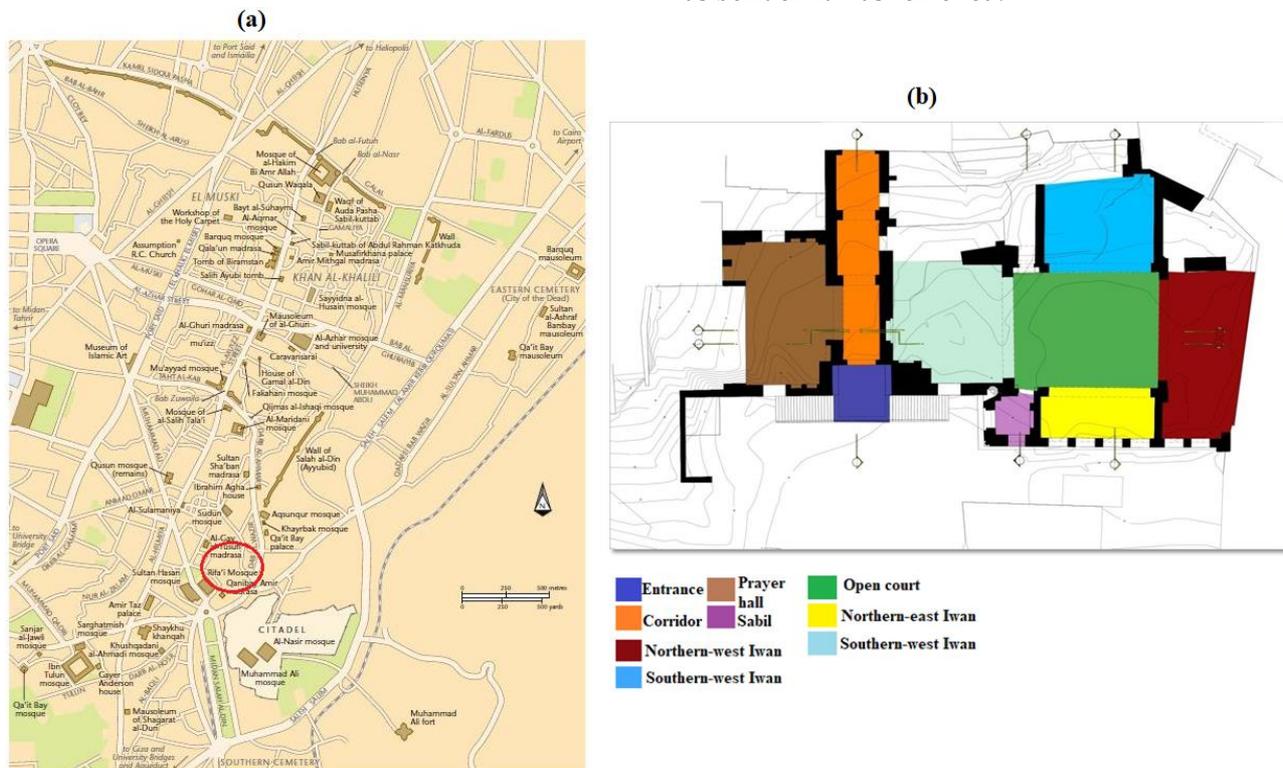
Figure 1. a) map of historic Cairo (after: Yeomans, 2006), the location of Al-Bimāristān Al-Mu'ayyidi complex is highlighted by red circle, b) a schematic plan of the buildings complex.

Bimāristān is derived from the Persian word to mean hospital. Al-Bimāristān Al-Mu'ayyidi (Figs. 1& 2) (under registration number: 257) was built by Sultan Al-Mu'ayyad between 1418 and 1420 AD (821-823 AH) (Holt, 1993; Behrens-Abouseif, 2007). It was the second public hospital built in Cairo after that of Qalawun at 1284 AD (682 AH) (Abdel Alim, 2003). It is noted for its monumental scale, unprecedented in a civic building, which was clearly inspired by the nearby free-standing grandiose Madrasa of Sultan Hassan, and also for its portal, which is set in a pishtaq, a feature which gives the facade a Persian character. The portal has a Muqarnas hood and a window with a pair of colonnettes with a snake, a symbol of healing. The Bimāristān is built on the site of the Madrasa of Sultan al-Ashraf Sha'ban, which was

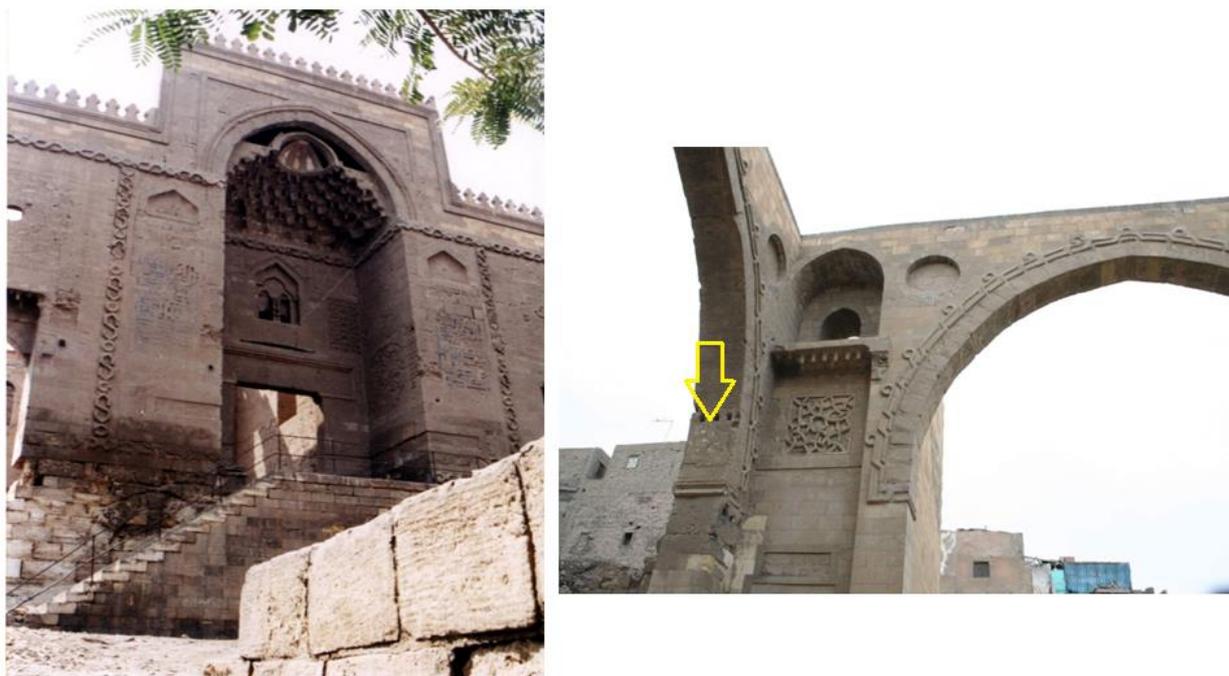
Figure 2. Left: the entrance unit of Al-Bīmāristān Al-Mu'ayyidi, before restoration; right: location of the surviving mural painting (highlighted with arrow) before complete uncovering and restoration.

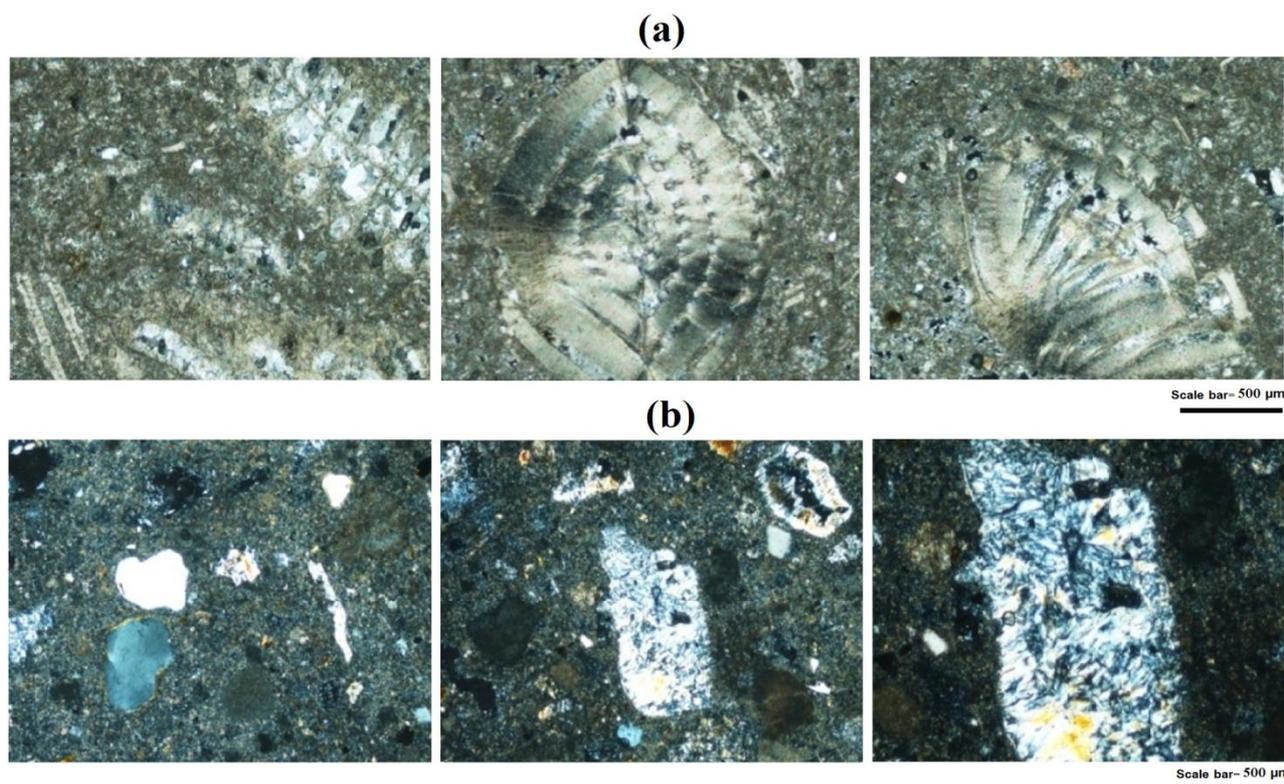
Figure 3. Crossed polarized light images (scale bar= 500  $\mu\text{m}$ ) of: a) stone sample, b) render layer.

Samples of the stone support were collected and studied. Understanding the mineralogical-chemical composition of the support helps in determining, in somehow, the deterioration mechanisms of the whole mural. The petrographic study on thin-sections of stone samples shows clearly a bioclastic-type limestone which contains several large-size fossils. The background of the section is filled with a micritic texture (Mahmoud, 2021). New formed fine calcite crystals were deposited into the cytoplasmic structure of fossils (Fig. 3a). Scanning electron microscope was used to identify the morphological aspects of stone samples. In Figure 4a, the FE-SEM investigation shows fine and large grains distributed into the micrograph.

The petrographic examination on render layers represented fine calcite crystals with quartz grains of slightly small size (Fig. 3b). FE-SEM micrograph on the sample represented fine-grained matrix with the absence of siliceous aggregates (Fig. 4b). EDAX analysis confirmed high percentage of calcium (37.18 %) (Fig. 4b, bottom). Minor concentrations of sulfur (S, 2.85%), chlorine (1.60%) and sodium (0.69%) come from accumulations of halite and calcium sulfate phases. XRD diffractogram of the powder sample resulted in form of calcite (93.8%) with few quantity of quartz (6.20%) (Fig. 5b). The results are in accordance with the microscopic examination which expressed the high amount of calcite in the render layer compared to the siliceous aggregates. Probably, a siliceous limestone type was burned to prepare the lime. Technically, lime is produced through burning limestone blocks, often at temperatures of 920-1000°C. But also, calcium oxide (CaO) can be obtained in reducing conditions at temperature  $\sim 850^\circ\text{C}$  (Rodríguez-Navarro et al., 2009). After that, the heated blocks are crushed to fine powder of quick lime, which then is slaked with water to form calcium hydroxide,

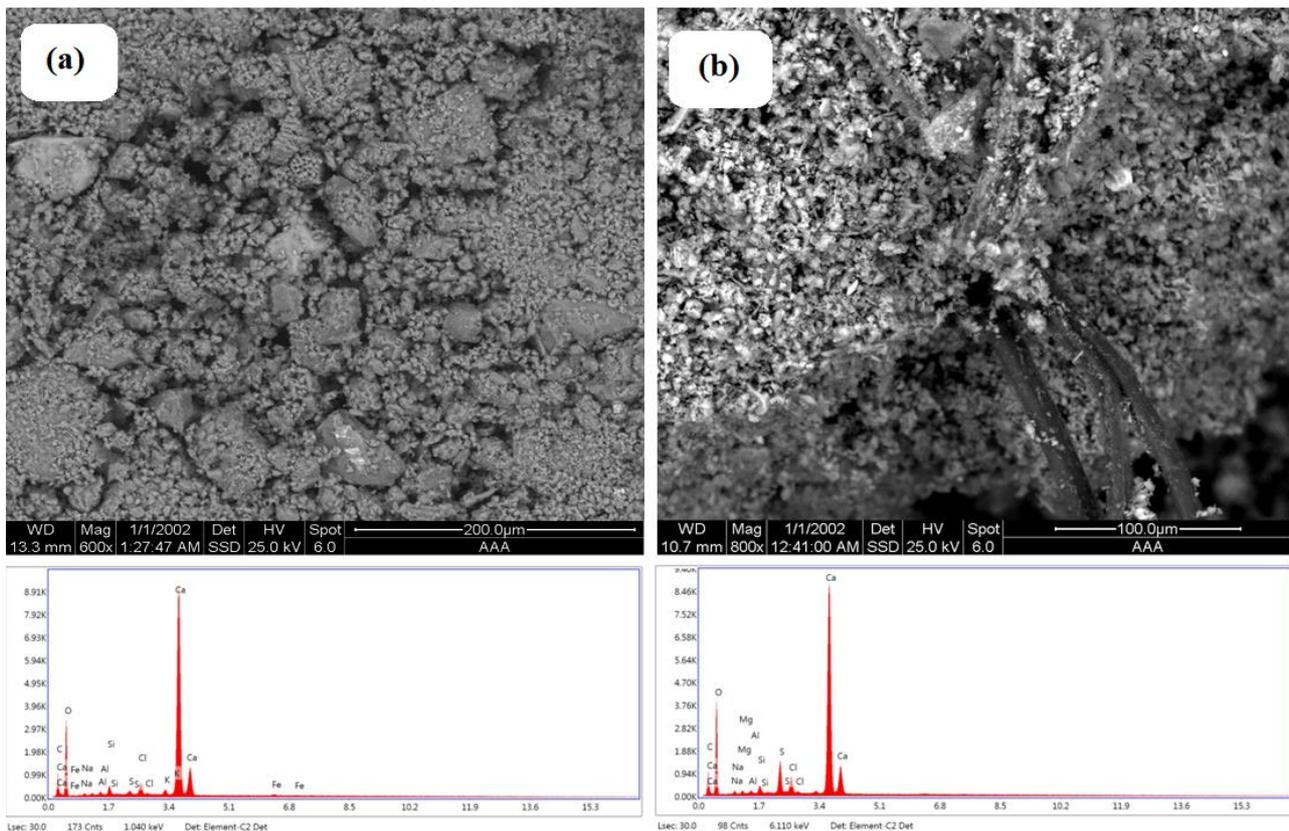
Figure 4. FE-SEM micrographs and EDAX spectra of: a) stone sample, b) render sample.

The EDAX spectrum of the sample (Fig. 4a, bottom) shows a major content of calcium with atomic concentration reached 41.51%. Traces of chlorine (Cl, 1.20%) and sodium (Na, 0.44%) were detected in the sample, which confirm halite salts (NaCl). The mineralogical analysis using X-ray diffraction method measured calcite ( $\text{CaCO}_3$ , 85.90%) and halite (14.10%) (Fig. 5a). Limestone was a major building material used in constructing several Islamic structures in Cairo. The stone blocks were provided from the nearby quarries, e.g. El-Mokattam quarry (Harrell and Storemyr,

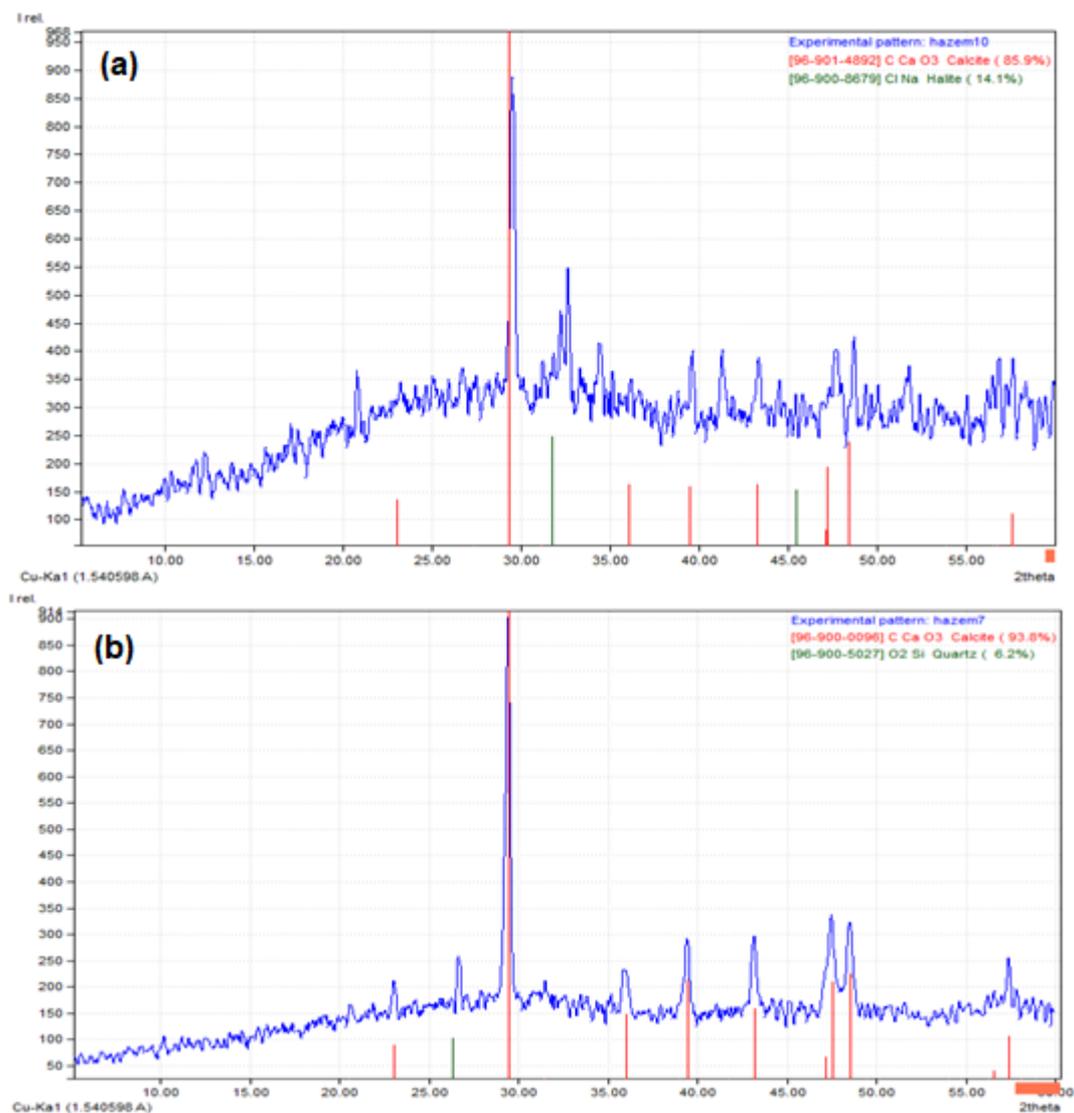
Figure 5. XRD diffractograms recorded on: a) powder stone sample, b) powder render sample.

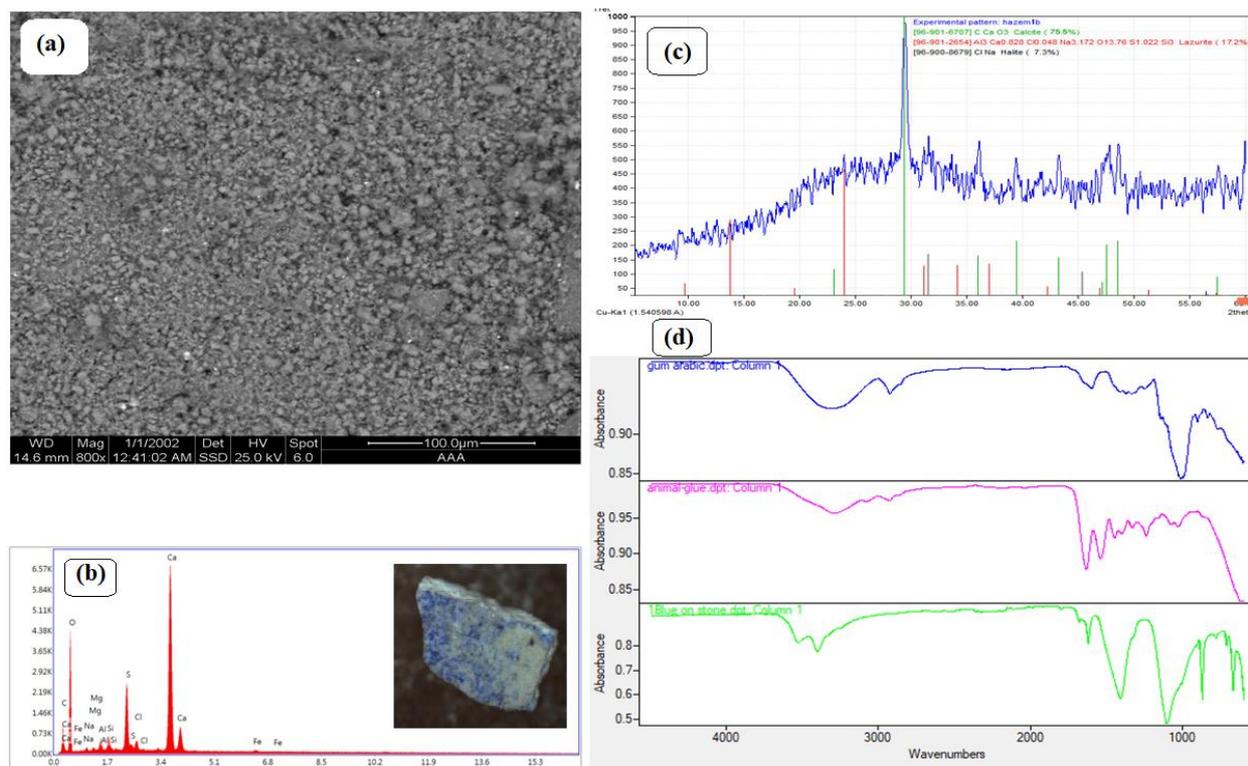
Figure 6. a) FE-SEM image of the blue paint layer, b) EDAX spectrum of the sample (a microscopic image is also presented), c) XRD diffractogram of the sample, d) FTIR spectra on the sample compared with standards of animal glue and gum Arabic.

The FE-SEM image scanned on the blue paint layer showed a homogenous distribution of fine grains (Fig. 6a). The EDAX spectrum (Fig. 6b) measured concentrations of sodium (Na, 0.58%), aluminum (Al, 0.76%), sulfur (S, 6.06), chlorine (Cl, 0.80%), and silicon (Si, 0.79). These characteristic elements suggest the application of ultramarine blue. The microscopic image presented in Figure 6b, shows deep blue grains of the pigment material. The mineralogical analysis, by XRD, showed the existence of lazurite (Na, Ca)<sub>8</sub>(AlSiO<sub>4</sub>)<sub>6</sub>(SO<sub>4</sub>S,Cl)<sub>2</sub> (Fig. 6c). The mineral lazurite forms the majority of the precious stone 'Lapis lazuli'. Lapis lazuli was used since pre-dynastic but its powder 'the ultramarine blue' likely was first used by the 5th and 8th centuries C. E. Ultramarine blue contains particles with size larger than >10 μm (Aceto et al., 2013). In the FTIR analysis of the sample, compared with standard spectra of animal glue and gum Arabic (Fig. 6d), recognizable bands of calcite and gypsum together with stretching vibration of S-S bond near 546 cm<sup>-1</sup>, correspond to lazurite, were identified (Bruni et al., 1999). Worthy to note that no organic material was identified, which ascertains the use of

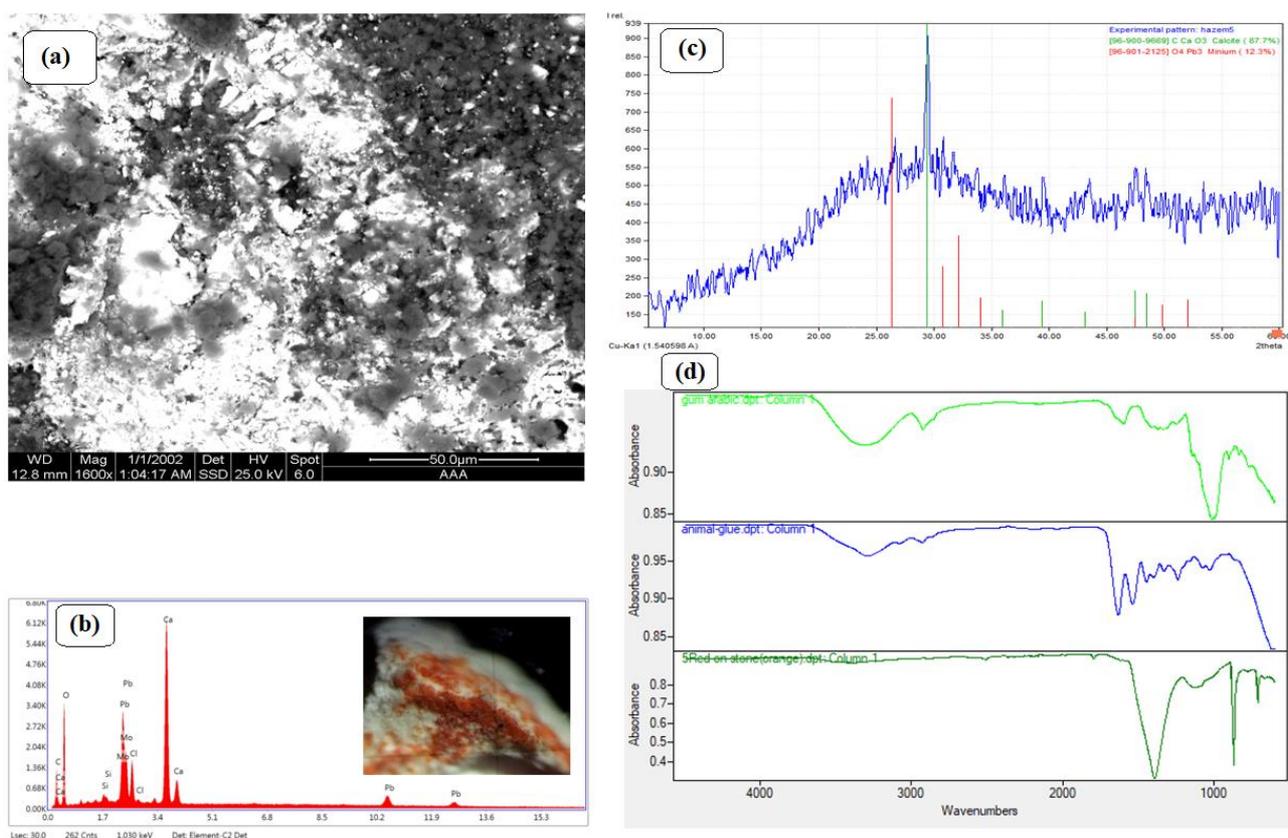
Figure 7. a) FE-SEM image of the orange-red paint layer, b) EDAX spectrum of the sample (a microscopic image is also presented), c) XRD diffractogram of the sample, d) FTIR spectra on the sample compared with standards of animal glue and gum Arabic.

The investigation of the red-orange paint sample by FE-SEM (Fig. 7a) showed a bright shiny surface which reflects the presence of heavy metals. Observing the EDAX spectrum, a high concentration of lead (Pb, 24.40%) (Fig. 7b) was measured. XRD pattern of the sample (Fig. 7c) showed minium (Pb<sub>3</sub>O<sub>4</sub>) as the coloring mineral in the sample. However red ochre was the principal coloring agent used in many chronological periods, but some other pigments such as realgar (As<sub>4</sub>S<sub>4</sub>) and red lead were used for red-orange hue. Red lead was a pioneer artificial pigment used for painting and it was reported in China by the 5th century BC. (Miguel et al., 2009). This pigment can be simply produced by the calcinations of basic lead carbonate (2PbCO<sub>3</sub>·Pb(OH)<sub>2</sub>), and also by the oxidation of litharge (Lead monoxide) (Aze et al., 2008). The size of particles ranges between 1 to 50 micron. Despite its vivid color, red lead transforms into black lead dioxide, by the effect of sulfuric gases. In their study of the discoloration phenomenon of mural paintings of Mogao Grottoes (366 AD), Zhao et al. (2016) realized

that the degradation of red lead pigment is linked to the humid microclimate and the microbiological effects with a fluent supply of  $H^+$  ions. In Figure 7d, the FTIR spectra of the red-orange paint layer, animal

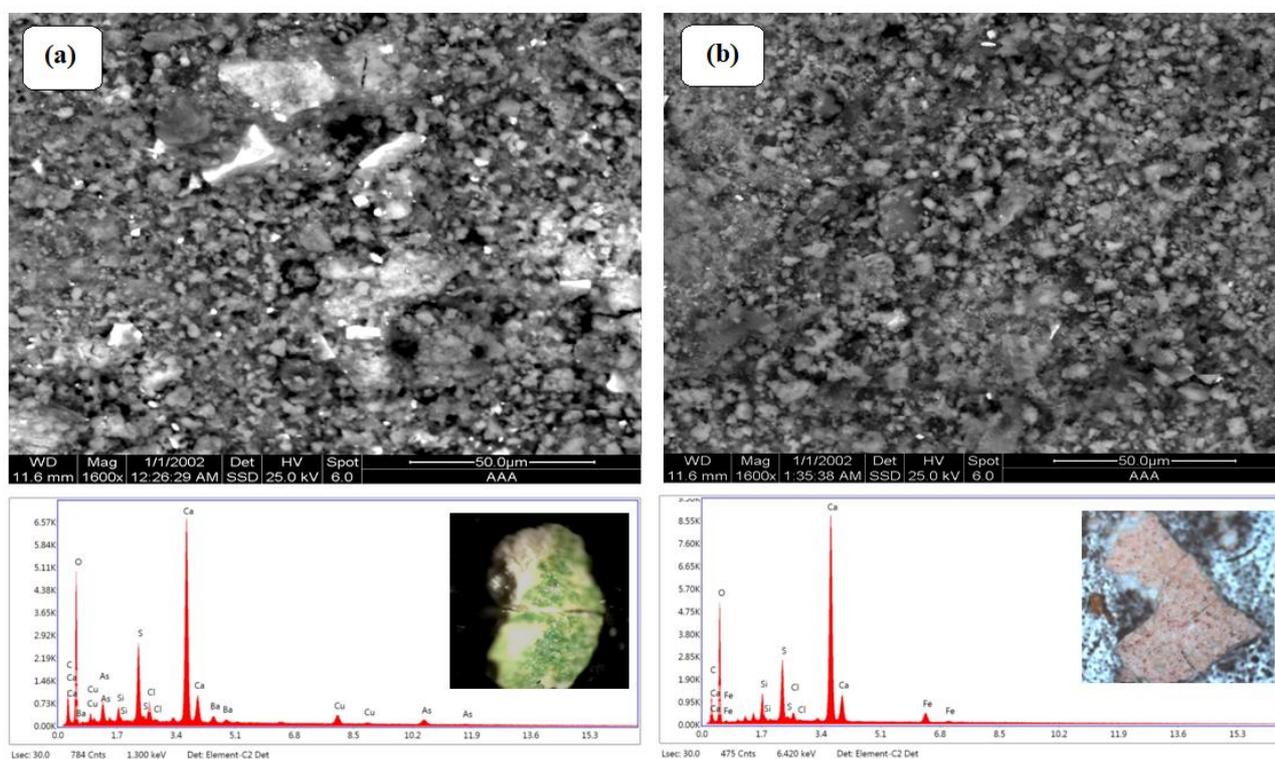
Figure 8. a) FE-SEM image (up) and EDAX spectrum (bottom) of the green paint layer, b) FE-SEM image (up) and EDAX spectrum (bottom) of the pink paint layer.

Analysis of the green paint layer showed interesting results. The morphology of the sample revealed coarse large grains together with bright crystals (Fig. 8a, up). The EDAX spectrum measured a wide group of elements including two featured elements, arsenic (As, 5.83%) and copper (Cu, 3.88%) (Fig. 8a, bottom). It seems that the ancient artist decided to create the green hue through mixing different pigments. Probably, a mixture of azurite ( $\text{Cu}_3(\text{CO}_3)_2(\text{OH})_2$ ) and arsenic-based yellow pigment (e.g. orpiment) was used. According to Lucas (1962), azurite probably was used as a pigment since the 4th Dynasty in Egypt (c. 2613-2494 BC). However, no strong indication was reported to support this argument. In his review article, Scott (2016) claimed that some researchers found azurite on different objects. Orpiment, as a royal pigment, was a brilliant yellow pigment imported to

For the pink paint layer, the FE-SEM image showed the grains of the pigment appeared fine with large ones of quartz (Fig. 8b, up). EDAX analysis measured calcium (31%) with few amounts of iron (3.14%) (Fig. 8b, bottom). Complementary concentrations of sulfur (5.12%) and silicon (1.93%) were found. The pink hue probably was produced by mixing portions of red hematite ( $\text{Fe}_2\text{O}_3$ ), gypsum and calcite. The amounts of silicon refer to quartz, while the absence of aluminum (Al) suggests that hematite rather than ochre was used. Hematite has a wide range of hues, of them, red-orange, red and bright red were the widely used throughout history (Marey Mahmoud, 2011).

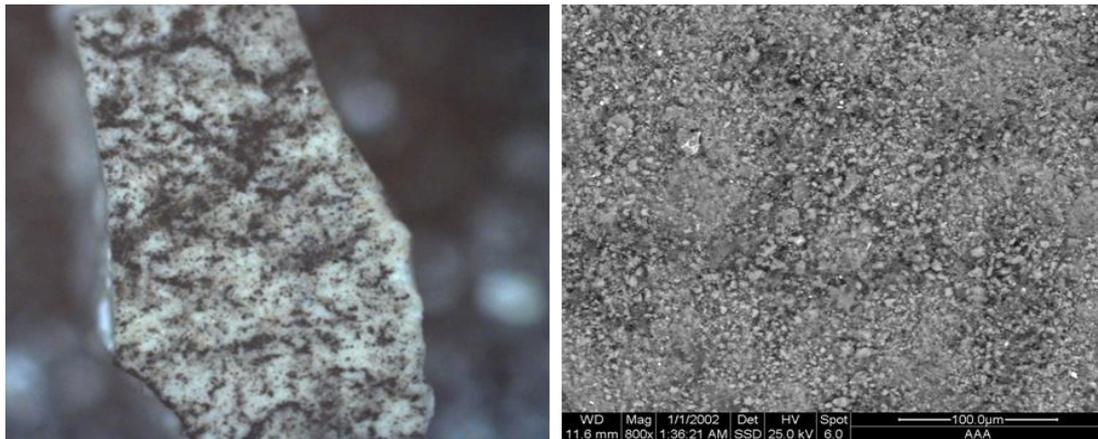
Figure 9. A microscopic image of the black paint layer (left) and FE-SEM image shows the fine particles of the pigment (right).

No characteristic features were documented for the black paint layer. The morphology of the pigment (Fig. 9, right side) excludes the use of charred char-

coal. Also, the microanalysis did not detect phosphorus in the sample. It was concluded that lampblack was used to produce the black color. Lampblack is one of the oldest known carbon pigments. It has fine particles that usually collected from soot results from oil lamps (Lliveras-Tenorio et al., 2019)

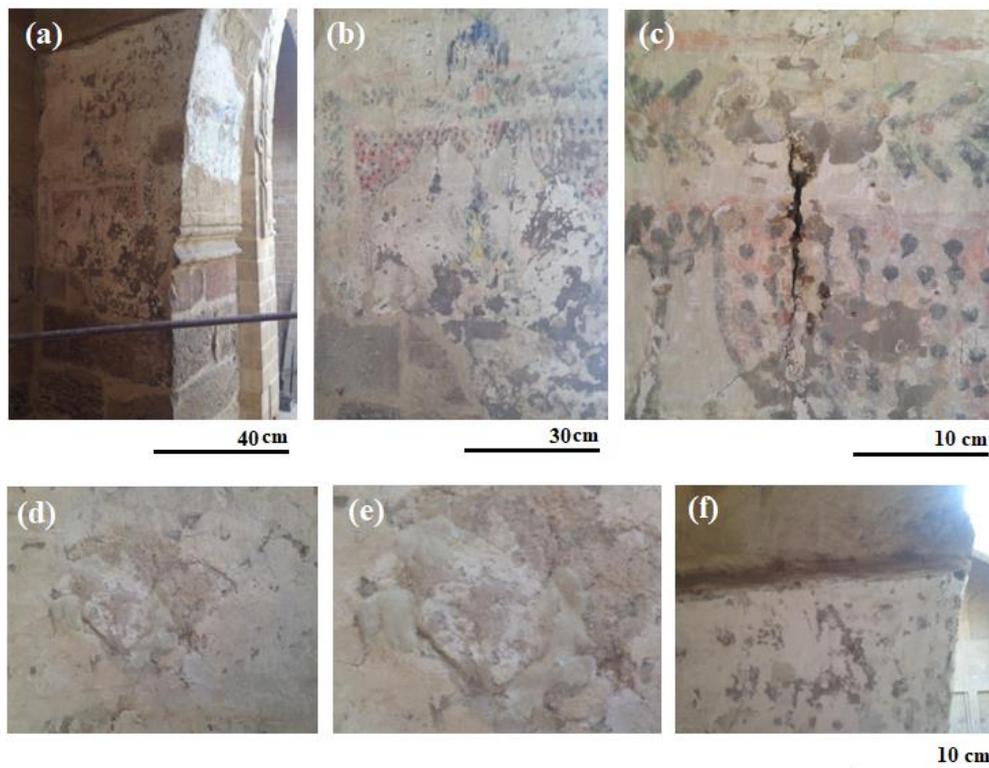
Figure 10. Photographic documentation of the studied mural, a) disfiguring of the mural, b) a close-up image of the previous image, c) crack, d-f) recent lime layers on the mural.

ral was photographically recorded, as the photographic documentation is one of the most important steps in the restoration work. Figures 10 & 11 represent photographic and drawing documentation of the main deterioration forms recorded on the mural. It was easy to record that the mural can hardly be seen due to fading occurred by the effect of time. Accumulations of recent lime layers, salts efflorescence, missing painted areas, several cracks and disintegration of the pictorial surface were observed. After fluffing the necessary documentations, several restoration steps were applied (Fig. 13).

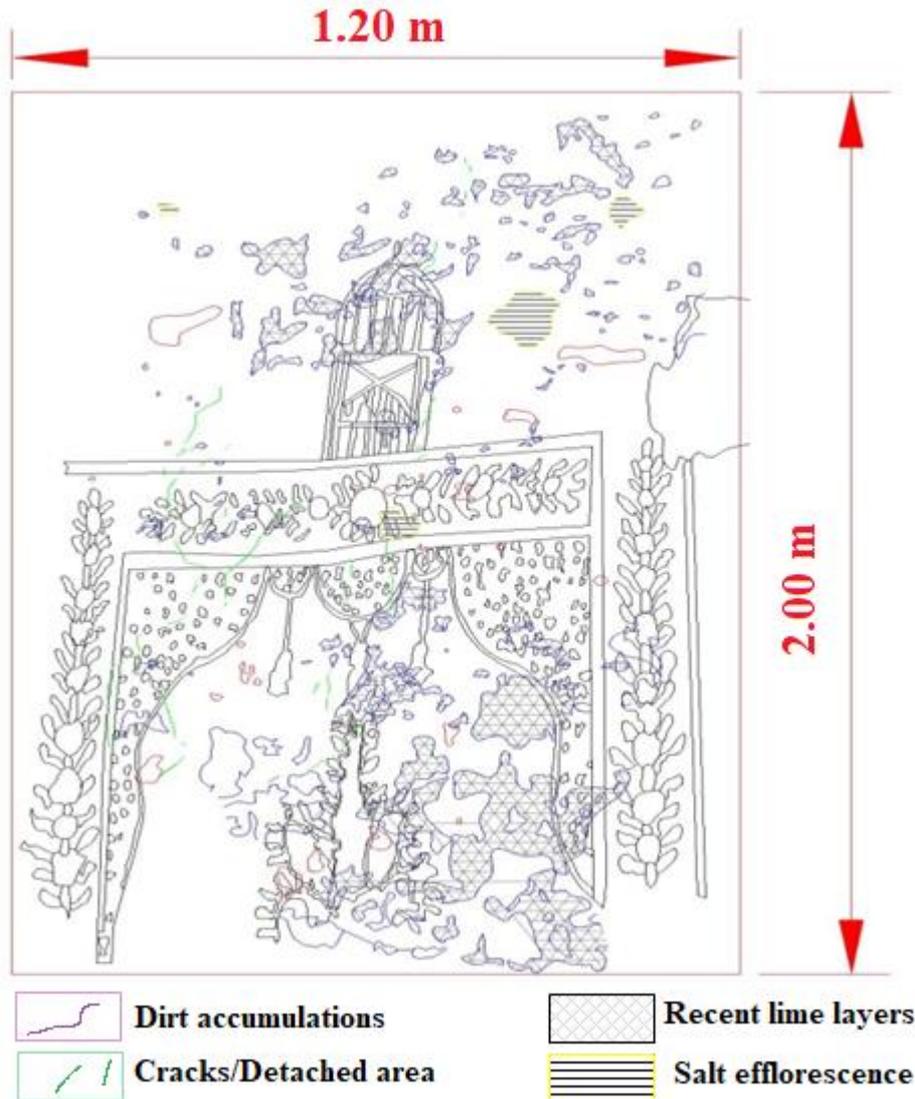
Figure 11. A map illustrating the main deterioration aspects on the mural.

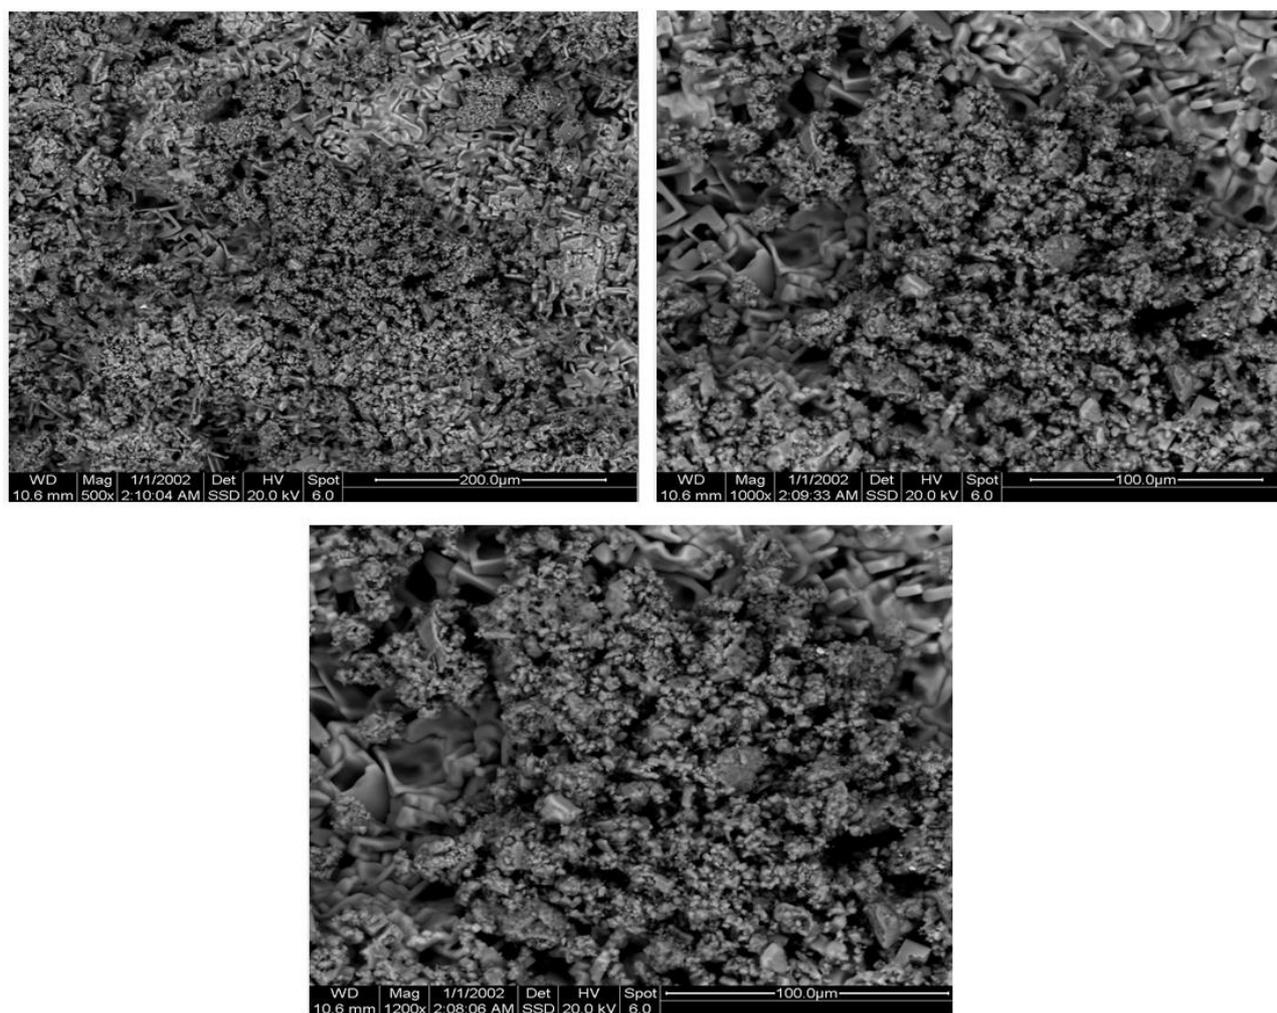
Figure 12. FE-SEM micrographs (at magnifications 500, 1000 and 1200x) of the treated paint layer with nanolime (5% in ethyl alcohol) after laboratory salt weathering.

dispersion of Nanolime (nano  $\text{Ca}(\text{OH})_2$ ), 5% dispersed in ethyl alcohol, was applied, for several times with an interval of a week after each application, using the brushing method. The surface was covered with polyethylene sheets to prevent the rapid evaporation of the alcohol. The scanning electron microscope was used to evaluate the consolidation process and stability of the nanomaterials against weathering factors. In Figure 12, the appearance of the prepared nano dispersion was evaluated by FE-SEM investigation after laboratory salt weathering. In the FE-SEM image, one can notice the high stability of the new formed crystals of calcium carbonate against etching that usually occurred due to crystallization of salts as previously reported by Al-Omary et al., (2018).

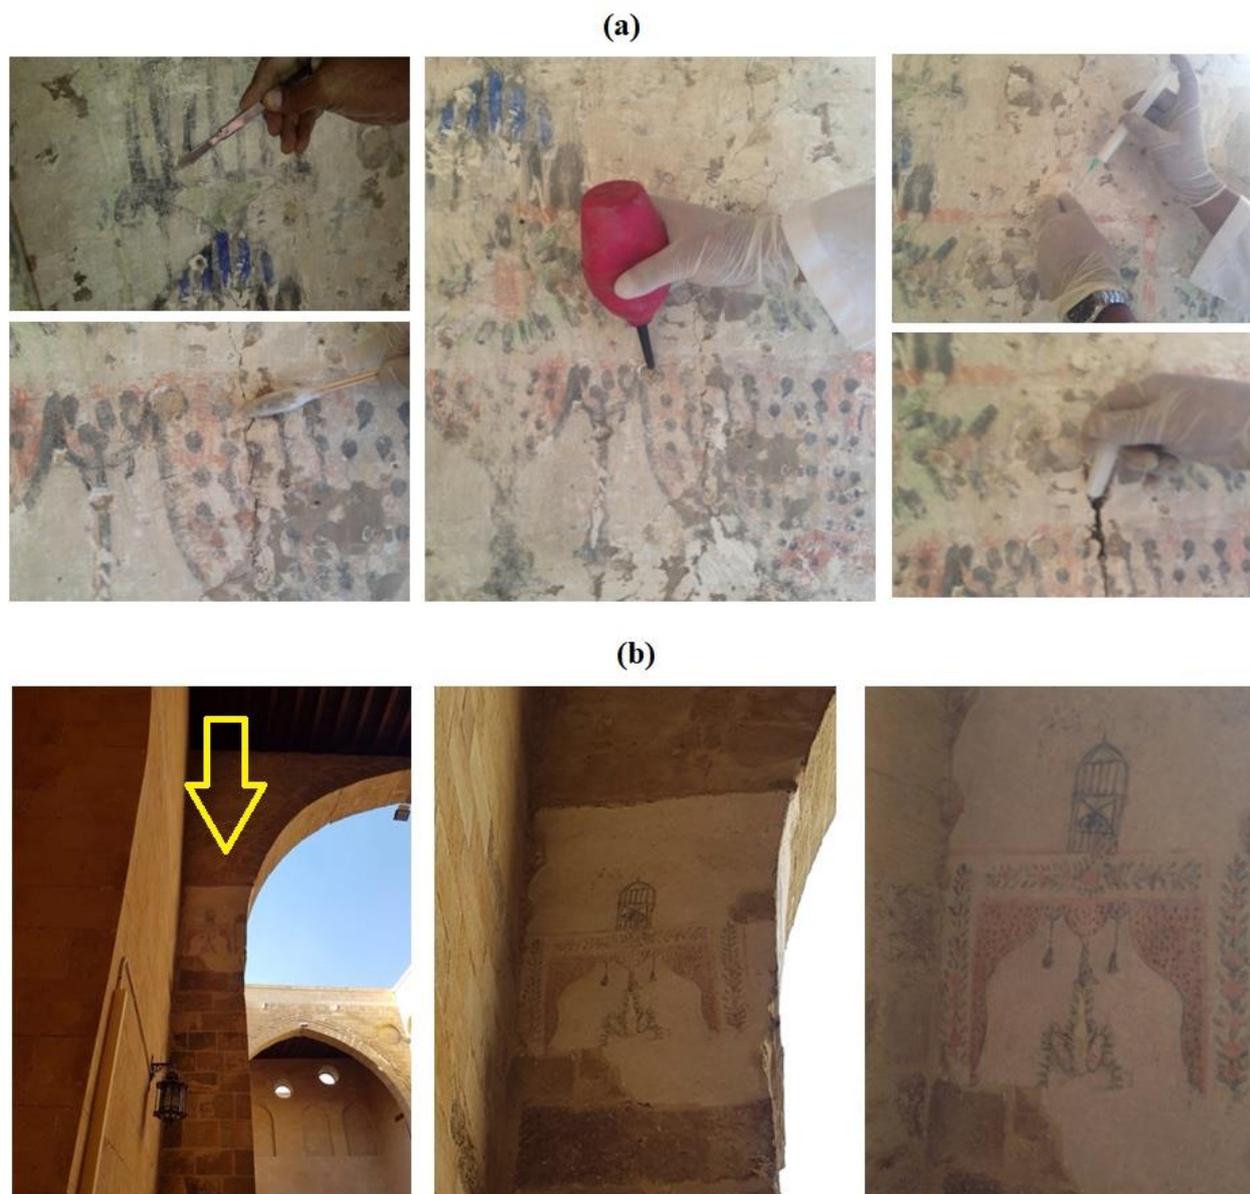
Figure 13. a) examples of the restoration procedures applied to the murals (e.g. cleaning, injection of open cracks, etc), b) the studied mural after the final steps of restoration (the yellow arrow refers to location of the mural).

sand, lime, Primal-33 and Wacker OH100 was injected into the voids of cracks. The mortar grout was applied with intervals to ensure a good penetration into the mural structure. For some detached paint layers, drops of Primal AC-33 (20%) were applied by syringes with the aid of gentle pressing on the separate parts to return them back to their original places.
