THE EFFECT OF THE GEOLOGICAL NATURE OF SIWA OASIS ON THE DETERIORATION OF ARCHAEOLOGICAL AND HISTORICAL BUILDINGS (THE TEMPLE OF ORACLE AND SHALI CASTLE)

Shaimaa Sayed Mohamed El-Sayed

*Conservation Department, Faculty of Archaeology, Luxor University, Egypt
(Egyptianconservators2013@gmail.com; shaimaasayed43@gmail.com)*

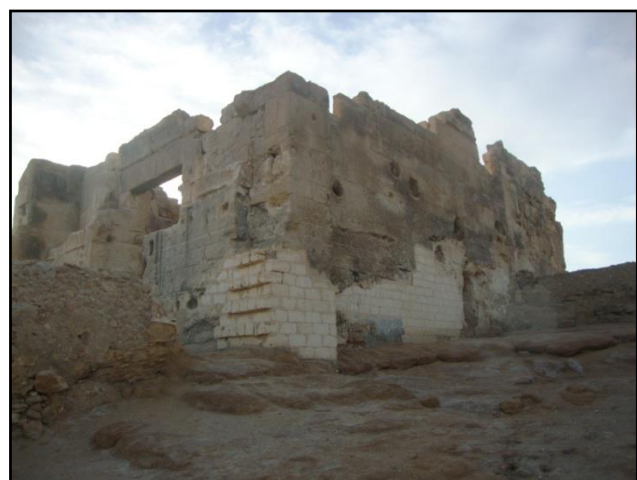
Figure 4. The Oracle temple in Siwa, which is built on Aghurmi rock

The town of Al-Aghurmi (where the Temple of Oracle to Amun) is built on a rock in the form of a fortified castle overlooking all neighboring sides, and at the bottom of the rock there are a large number of explosive springs, this village is one of the first villages built in Siwa in the Middle Ages in the wake of the end of the Amun temple era and the end of the Roman era, Aghurmi was built of mud and stones on a rocky hillside next to the Temple of Oracle (Abdel Motelib, A., *etal.*, 2015). Ahmed Fakhry mentioned that the oracle of Amun spread his fame in Siwa in all the Mediterranean countries since the beginning of the twenty-sixth dynasty (Fakhry, 1973), and the Temple of Oracle for Amun was established in the oasis and Alexander the Great visited in The Ptolemaic era, where this visit is the most famous of the visits that took place to this temple in the Siwa Oasis, and it was also mentioned that the Temple of Oracle in Siwa was not used for the consecration of Alexander the Great and that the only temple that was used to consecrate Alexander the Great is in the Bahariya Oasis (Darwish, 2010).

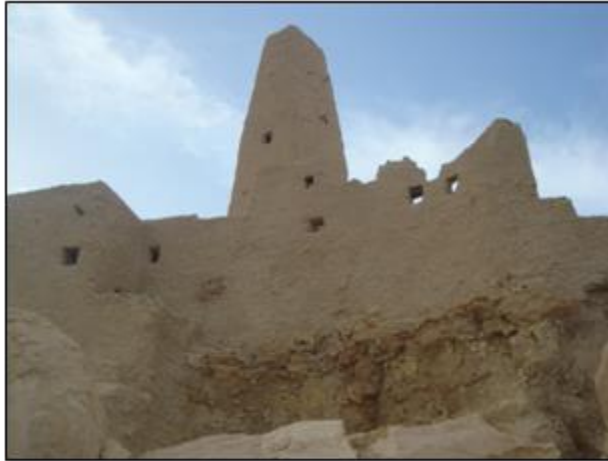
Figure 5. Historic Shali Castle

The era of salty buildings in Shali dates back to the 12th c. AD and the thirties of the 20th century, and now the castle of Shali looks like a succession of ruins of walls with small windows. Inside the castle, especially in small houses, it is noticed that palm trunks are used in the process of linking the walls, and the outer walls are covered with clay mortar, al-Kurshef is the basic building material for these buildings (Figs 5, 7).

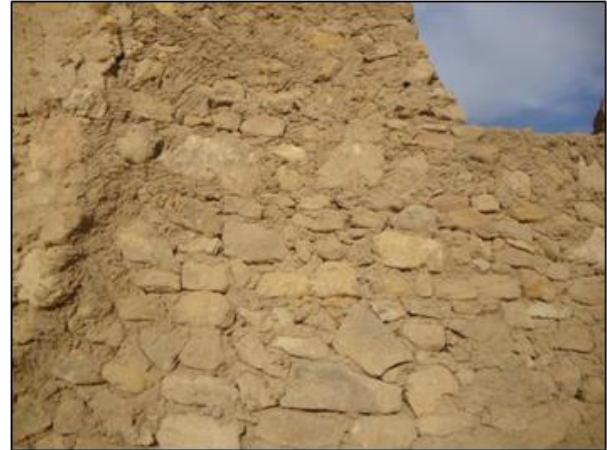
Figure 6. Building with Al-Kurshef blocks and mortar in the historic Shali Castle

Al-Kurshef consists of crystals of halite salt "sodium chloride" with impurities of clay and sand. It uses irregularly shaped blocks taken from the surrounding salt lakes. It has been cut into smaller blocks, used in construction and attached to a salt-rich clay mortar. During the drying process, a strong link occurs between Salt and mortar blocks, due to NaCl crystals of halite salt inside the mortar itself.

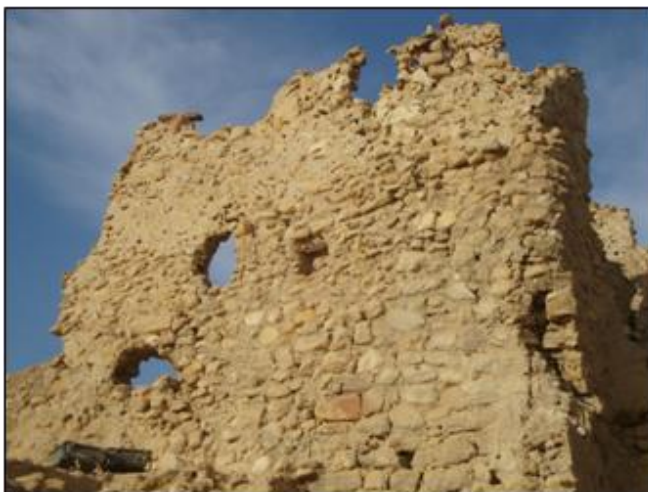
Figure 7. One of the walls in Shali Castle, which was built from Al-Kurshef, and it becomes clear that there are deep cracks and separation in the walls.

From a survey of the external walls of the building, it is noticed that tree branches are used in the walls, especially the edges, so Siwa Oasis architecture is characterized by its weakness, which exposes it to unexpected damage.

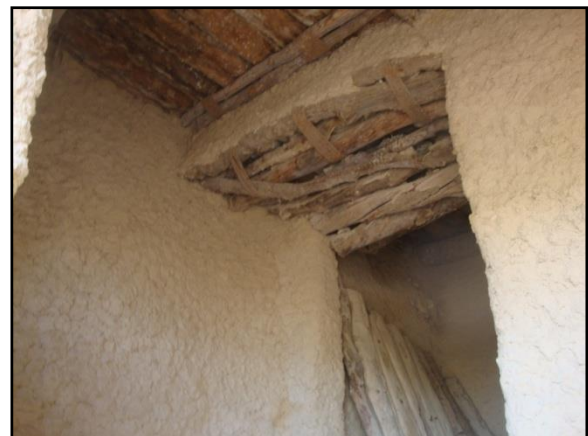
Figure 8. The use of wood in joining the walls and roofing of one of the old houses in Shali Castle built from Al-Kurshef

Palm wood is used as wooden bars in building walls, and these woods are distinguished as a material that is easy to perish as it is subjected to vertical displacements in small loads, and the walls are characterized by the presence of cracks and separations especially at the perpendicular walls "the area of edges and corners", as well as under the bars of palm wood and above, and the mechanics of these cracks and separations must be studied to Preserve These Buildings (Fig 8).

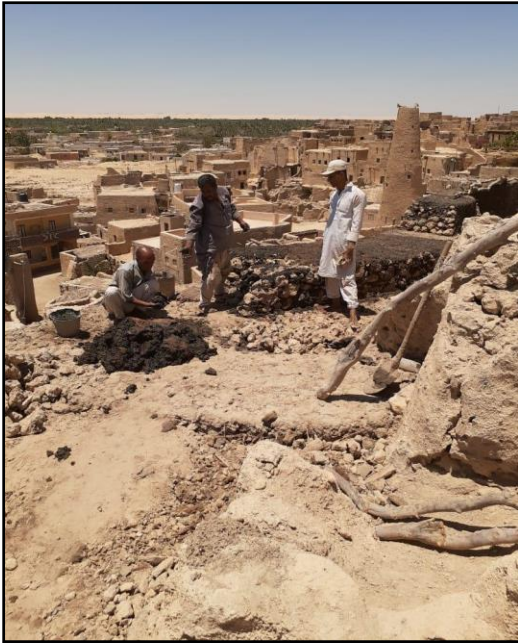
Figure 9. The people used the same old construction technique with Al-Kurshef in building modern houses

The old construction method in al-Kurshef is still used today in building the homes of the people of Siwa Oasis (Rovero *et al.*, 2009, 2492.) (Figs 9,10).

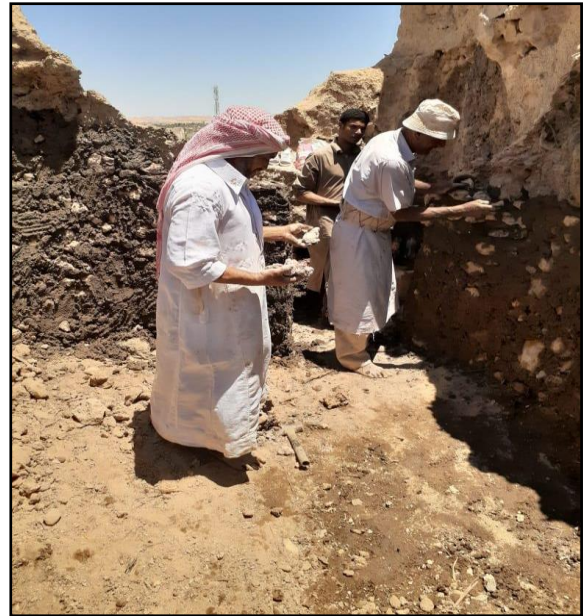
Figure 10. Building a modern wall using Al-Kurshef

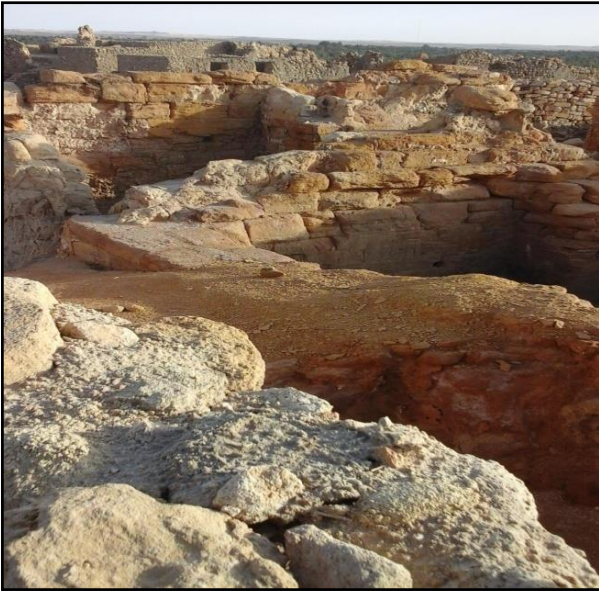
By analyzing the limestone sample taken from the temple by X-Ray Diffraction, it was found that the percentage of halite salt (sodium chloride) in the sample is 45%, which is a very high percentage as previously mentioned because the halite salt is a component of limestone, and that geological nature resulted in many deterioration phenomena to the temple are as follows:

1. Fragmentation and loss of limestone due to exposure of halite salt to cycles of dissolution and crystallization.

Figure 21. The crumbling and degradation of the saline limestone at the Temple of Oracle in Siwa

As cracks of all kinds and degrees are spread, which exposes them to annihilation and extinction, it is recommended to carry out restoration operations such as reinforcement, as well as isolation of traditional building materials from sources of moisture to preserve this unique cultural heritage for future generations. Sodium chloride salt (which is a major component of these materials) is considered one of the salts. The multiple cycles of dissolution and crystallization - solubility in water and crystallization during drought of this salt - threaten this unique cultural heritage, which is a testament of the ancient Egyptian architecture and the great Egyptian civilization.

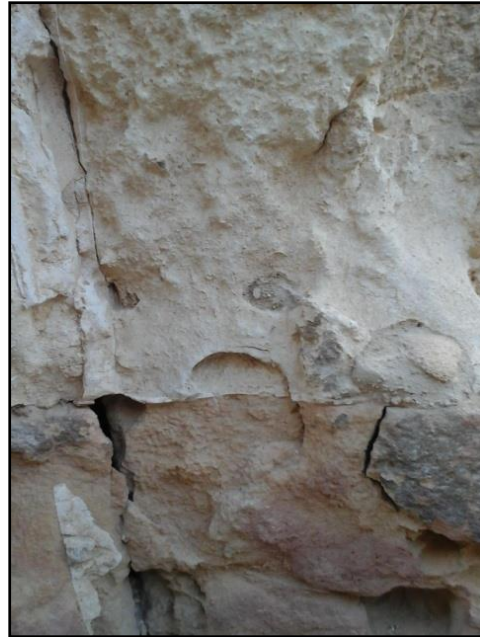
Figure 23. the crumbling of the saline limestone surface as a result of the saline geological nature of the Siwa Oasis - the Oracle Temple

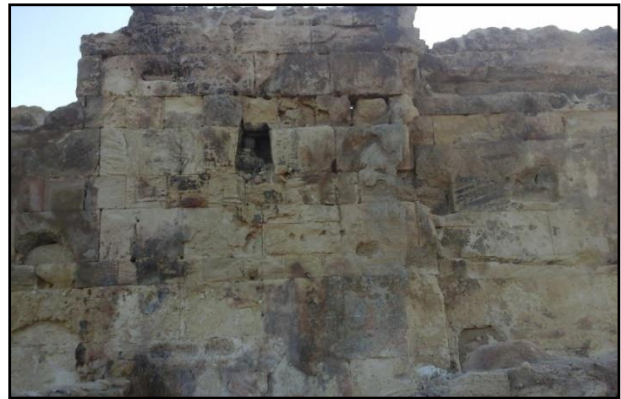
2. The occurrence of many fissures and cracks in the walls of the temple.

Figure 24. Saline limestone eroded and cracks spread in one of the walls - the Oracle temple

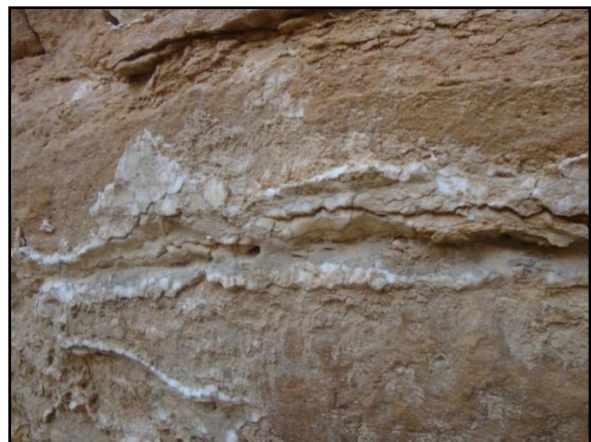
Figure 25. Salt deposits on the surface of limestone - Temple of Oracle, Siwa

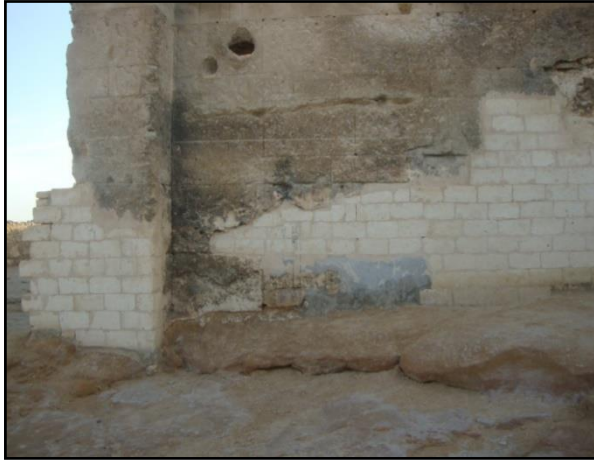
Figure 26. One of the completion of the walls of the Temple of Oracle, as a result of the weakness and erosion of the saline limestone

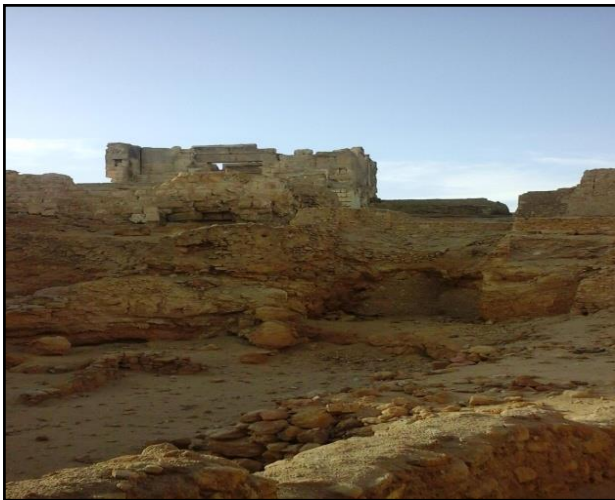
3. The temple is built on the Aghurmi rock, which suffers from weakness and cracking, and is structurally threatened by collapse at any time, and therefore this threatens the safety and survival of the temple, and this rock is part of the geological nature of Siwa Oasis (Figs 21,27).

Figure 27. The Aghurmi rock, on which the Temple of Oracle is built, is threatened with collapse at any time, threatening the security and safety of the temple

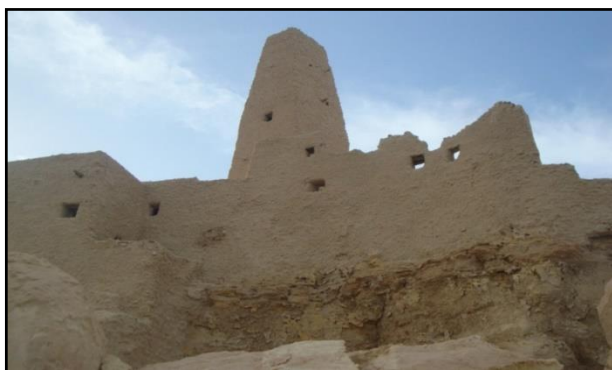
Figure 28. Al-Kurshef is damaged and eroded at the bottom of one of the walls of the historic Shali castle, which exposes it to partial or complete collapse

1- The fragmentation of al-Kurshef material and its loss in many places in the castle.

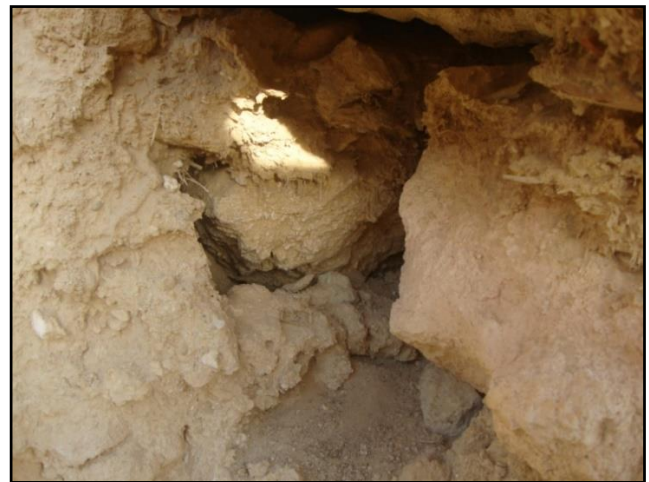
2- The presence of clear fissures and cracks in the walls caused by the weakness of al-Kurshef.

Figure 29. The weakness and fragmentation of Al- Kurshef in the eroded part of the walls - the historic Shali castle

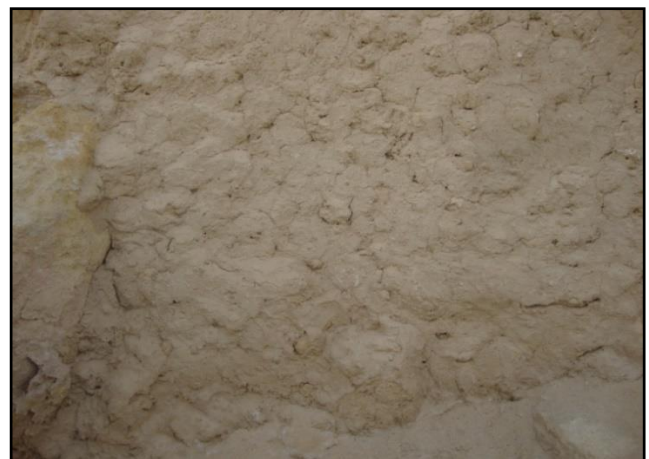
3- It was lost in al- Kurshef mortar as a result of its weakness (Figs 28,30).

Figure 30. Salt fluorescence on the surface of the mortar due to the saline nature of Al-Kurshef - Shali Castle
