# SEISMIC VULNERABILITY ASSESSMENT OF A 17<sup>TH</sup> CENTURY NEAPOLITAN FARM

Giovanna Longobardi & Antonio Formisano

In this paper, seismic vulnerability appraisal, restoration, and consolidation plan of a 17<sup>th</sup> century masonry building (Rossi farm) with cultural and artistic value located in a small city near Naples are reported and discussed. This case study is presented and described, providing historical data and information about its actual conditions, spaces, functions and structures. Once the crack pattern detected in the building has been appropriately traced, the knowledge is deepened by performing all the three seismic risk assessment analyses proposed by the "Italian Guidelines for the assessment and reduction of seismic risk of cultural heritage". The first evaluation level is a qualitative and simplified tool allowing for the knowledge of the risk level of the building under study. Afterwards, the structure has been subjected to more accurate investigations dealing with its local mechanisms and global behaviour in the second and the third evaluation levels, respectively. In all three analysis phases, the results have shown the high vulnerability of the m

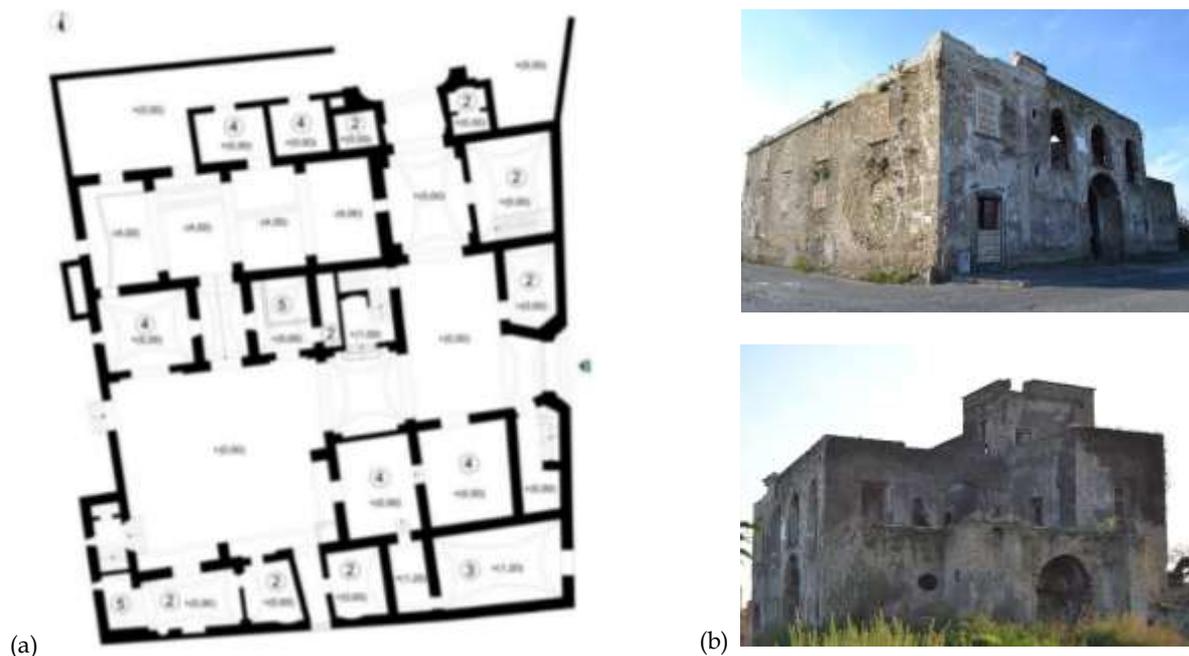
The structure occupies an area of about 1000 m<sup>2</sup> and it is developed on three levels. The ground floor of the building is shown in Figure 1a. The vertical structure is made of tuff stones, a common construction material in the Neapolitan area. Internally, there are most masonry vaults covering locals, whereas only three rooms have chestnut wooden floors as horizontal structures. Two external views of the farms are plotted in Figure 1b.

Figure 1. Ground floor layout (a) and external views (b) of the Rossi farm

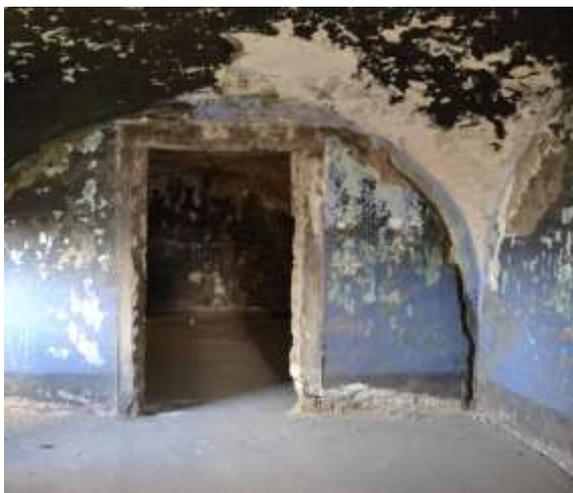
- Earthquake damage, which led to detachments between vertical masonry and floors. (Fig. 2)

*Figure 2. Earthquake damage*

- *Interventions to reduce detachment between vertical masonry walls and floors:* their aim is to ensure a good overall behaviour of the construction by making clamps between the walls and between them and the intermediate floors.
- *Intervention to increase the resistance of masonry piers:* their purpose is the increase of mechanical properties of damaged walls using compatible materials with existing ones. In this category are included the “*scuci*”

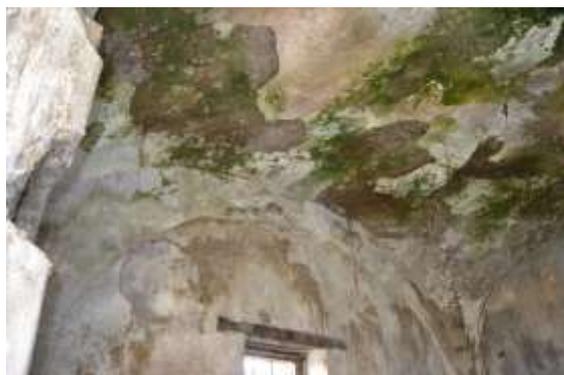
- Injuries on the first level's intrados of vaults and arches produced by past seismic events. (Fig. 3)
- Crushing of masonry walls, due to the increasing of loads and the age of materials. (Fig. 4)
- Detachment among walls dating back to different periods and between vertical walls and horizontal floors.
- Reduction of the resistant section of load-bearing elements due to humidity problems.
- Widespread phenomena of wooden floors decay with their partial or total collapse, the fall of planking, and excessive inflection of main beams leading to unwarranted deformability. (Fig. 5 - 6 - 7)
- Collapse of a part of staircase due to the failure of the roof after Vesuvius eruption. (Fig. 8)

*Figure 3. Injuries on the intrados of masonry vaults*

- *Interventions to consolidate masonry vaults and arches:* they could be made using innovative materials (as Fibre – Reinforced Polymers) or traditional techniques. (Borri, 2003)
- *Interventions for the consolidation of openings in masonry:* steel hoops.
- *Interventions for wooden floors:* they are proposed to limit their deformability and to ensure a better connection with the perimeter walls. In this typology, there are many possible operations such as the reconstruction of collapsed floors, the replacing of the beam heads, the insertion of dry connectors, or the installation of a second plank.

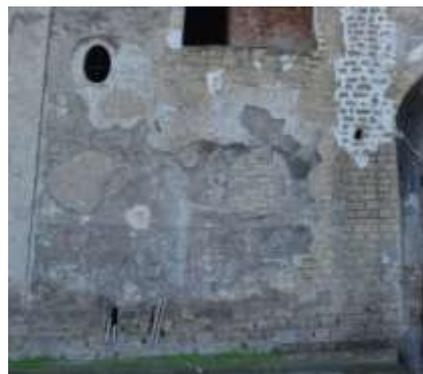
*Figure 4. Crushing phenomena on masonry walls*

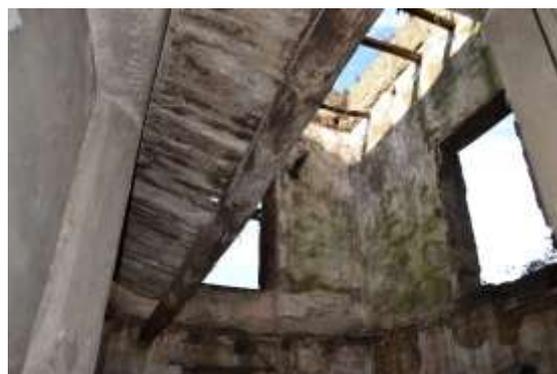
*Figure 5. Widespread phenomena on the wooden floor - Partial collapse*

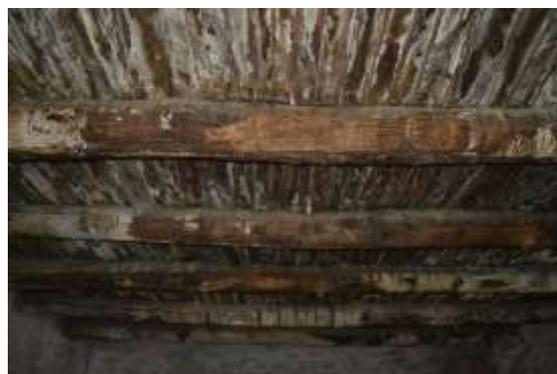
*Figure 6. Widespread phenomena on the wooden floor - Inflection on the main beam*

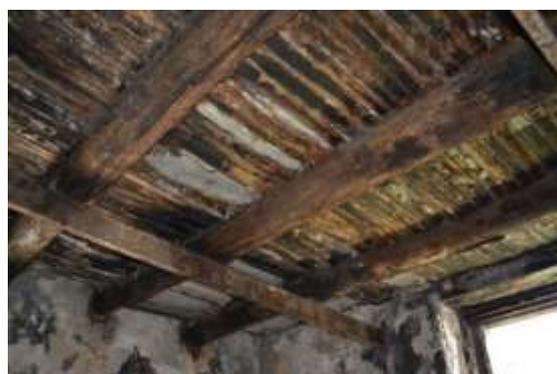
*Figure 7. Widespread phenomena on the wooden floor - The fall of the planking*

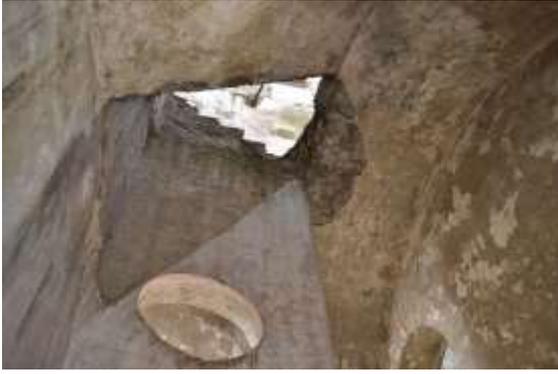
Figure 8. Collapse of a part of staircase

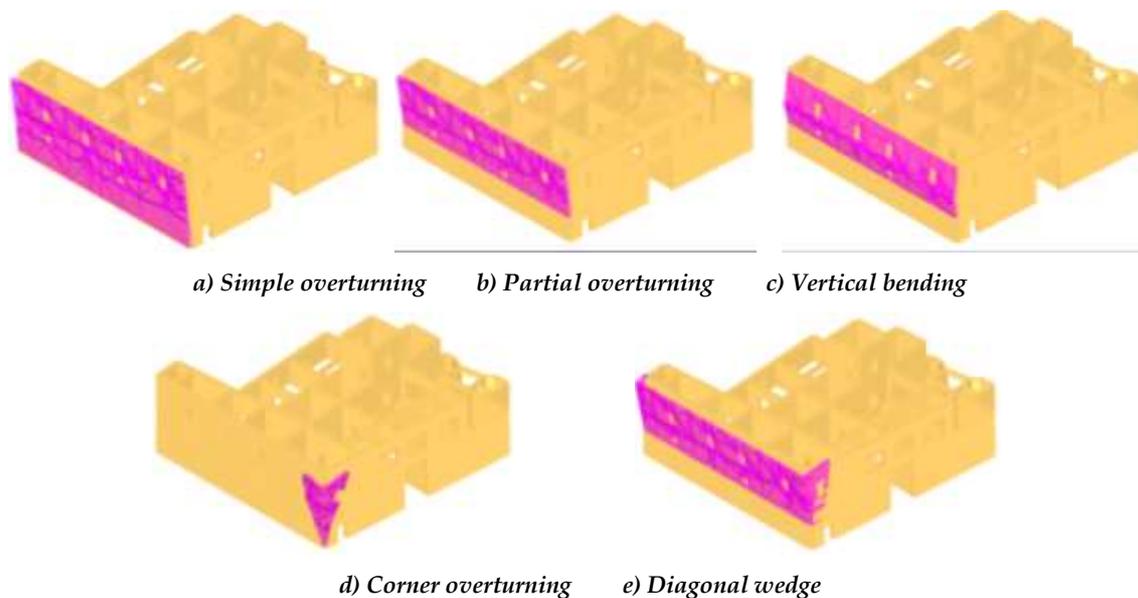
In the present case, simple and partial overturning, vertical bending, corner overturning, and diagonal wedge overturning have been considered as local mechanisms (Fig. 9) (Milano et alia, 2009; D'Ayala et alia, 2003; Faccio, A.A. 2012-2013). They have been evaluated by modelling the structure with the

Figure 9. Local mechanisms studied with the TreMuri software

Each mechanism has been verified for the perimeter walls of the building and the results are in most of the cases not satisfied, as depicted in Table 5, where, for each considered mechanism, it is reported the number of analyses performed on walls with positive and negative check results.

The local analysis results carried out on the farm have shown that the structure exhibits a high degree of vulnerability towards first mode mechanisms. Among the various mechanisms studied, simple overturning represents the most dangerous phenomenon affecting the seismic behaviour of perimeter walls. This result could be due to the lack of connection between two adjacent tuff masonry walls and between them and the horizontal structures. Thus, the wooden floors do not show good connections to vertical panels and the thrusts of masonry vaults increase the exposition to overturning phenomena.

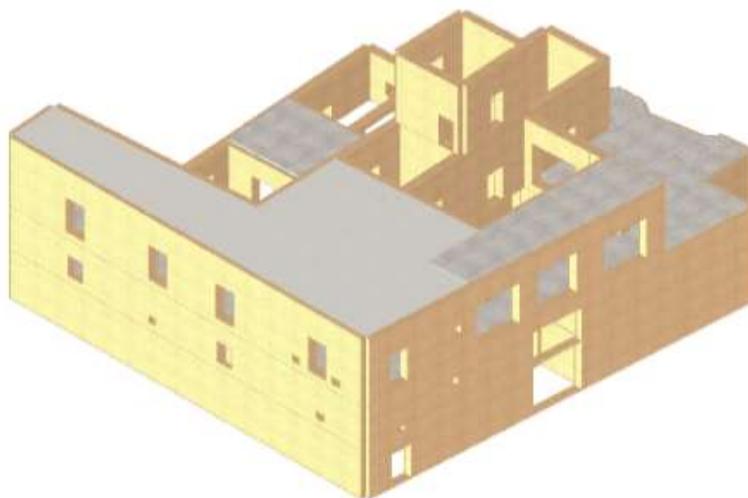
modelled through a macro-element approach with the TreMuri software (Fig. 10), using non-linear static analyses. Pushover analyses have been carried out considering the two distributions of horizontal forces considered by current standards, which lead to consider 24 different load combinations considering the variation of the seismic direction and the eccentricity of the seismic mass.

Figure 10. 3D Model of the Rossi farm

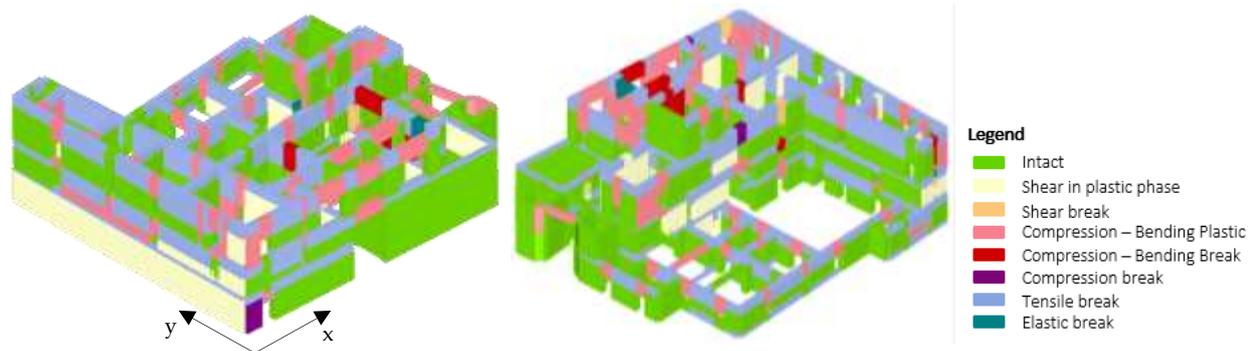
With regards to the analyses, the software provides the results of principal damages on the 3D Model of which we report the results related to analysis Nr. 19 (in the y-direction) (Fig. 11). It shows that the main

damages are the compression-bending (in pink) and tensile plastic phenomena (in blue) for the spandrels.

Instead, except masonry piers that remain intact, the governing mechanisms for them are the compression - bending (in red) and shear (in yellow).

Figure 11. Results of analysis Nr. 19 (Y Direction) on 3D Model

The results of EL3 analysis have shown that, as in the case of EL1,  $y$  is the weakest direction. Herein, the  $q^*$  factor is greater than three, which is considered as the maximum value allowed by the standard. In the  $x$  direction, checks are not satisfied and also in this case, the  $q^*$  factor is greater than the limit value.
