# INTERDISCIPLINARY PROJECT FOR THE CATHOLICON REHABILITATION OF THE VARNAKOVA MONASTERY

The Monastery of Varnakova is one of the most important and oldest religious complexes in Greece with high historical significance. The Catholicon was reconstructed in 1831 on the remains of the 11th century structure. Today it is in a bad state of preservation, as it has been severely affected by strong earthquakes and presents serious problems regarding both its stability and aesthetic values. Because of the importance of the monument and taking into account its poor state of preservation, a thorough diagnostic study was conducted through an interdisciplinary approach, which involved historical, architectural and structural analysis, as well as materials characterization and diagnosis of decay patterns, in order to propose an optimized rehabilitation plan. Techniques used included a 3D laser scanning and photogrammetric techniques, UAV images, a Total Station survey, 3D textured model using various techniques and software, prospection by ground penetrating radar (GPR), infrared thermography (IRT), finite element (FE) software, X-ray diffraction (XRD), Differential Thermal and Thermo-Gravimet

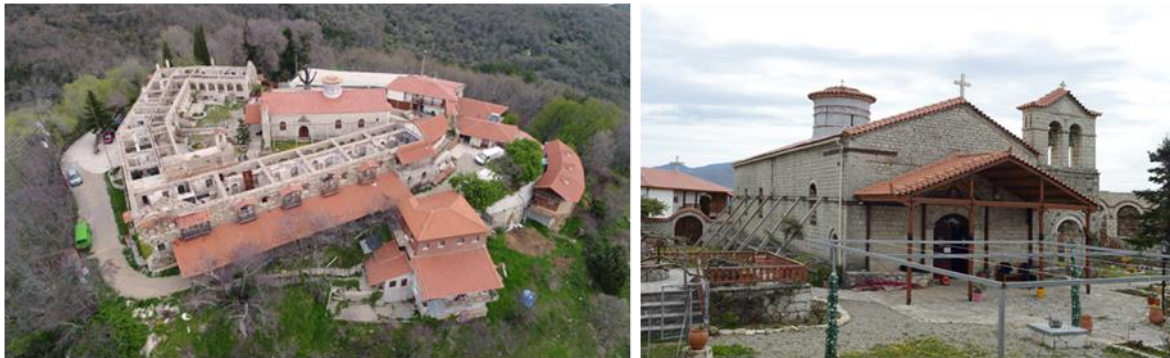
*Figure 1: Monastery of the Assumption of the Virgin Monastery complex (left image) and the Catholicon (right image)*

The complex of the monastery includes the Catholicon, which belongs to the architectural type of the three-aisled basilica Basilica with a dome, a narthex, and the modern building complex of the Kellia (dormitories). The architectural type of the Basilica although it formed the first typological base for Byzantine architecture, as adopted by the Roman judicial buildings, it was later on transformed receiving a central dome and changes in the apses of the altar and was extensively revived during the period of the Comnenian dynasty (Soteriou, 1942). It is built with coarsely worked limestone characterized by Orlandos as hammered denoting the type of craftsmanship and the processing of the stone (Orlandos, 1922). The Catholicon preserves the decorated Byzantine inlaid marble floor of the 11th century (Figure 2), and in the superstructure of the exonarthex a fresco of the Virgin in the type of Hodegetria is also preserved, dating from the late Byzantine period. The frescoes and the wooden Templon date during the period 1831-1838, when the temple was rebuilt. P. Kalonaros in his study of Varnakova (Kalonaros, 1957) also refers to an important collection of archives and books kept in the library of the monastery, all of which is now lost, but a part of it still testified in the State General Archives, in the work of D. Xanalatos (Xanalatos, 1939) and in sporadic references of other monks' work. The belfry was built in the southwest corner in the first decades of the 20th century by the state architect Gasparis, while the wooden tiled roof outbuilding was added to the west side of the narthex in the 1990s.

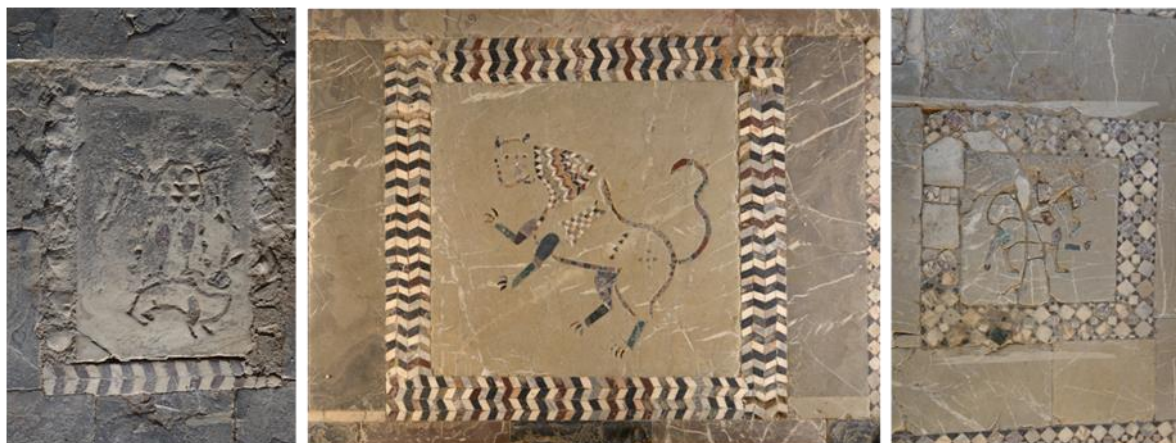
*Figure 2: Elements of the decorated Catholicon floor rich in animal and geometric representations. The decorations extend almost to the entire surface of the main church floor*

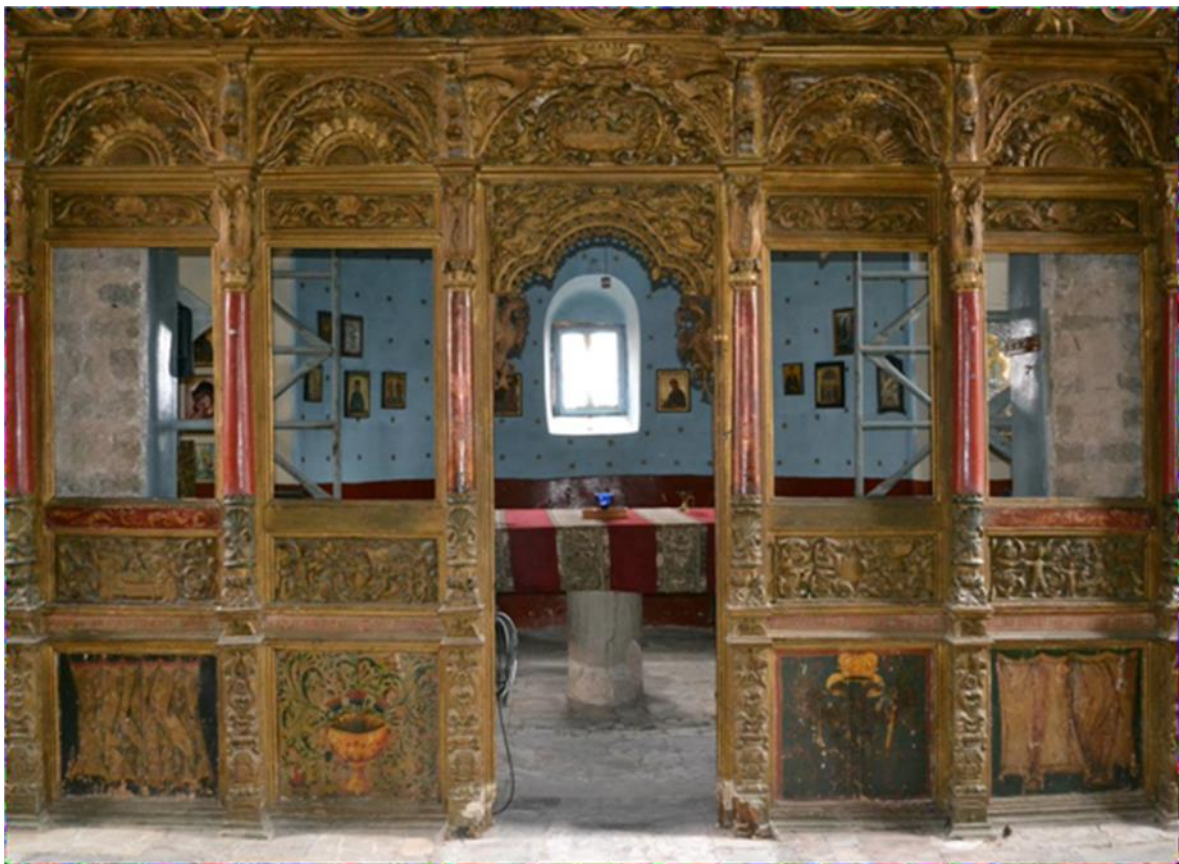
*Figure 3: Image of the Catholicon wooden Templon*

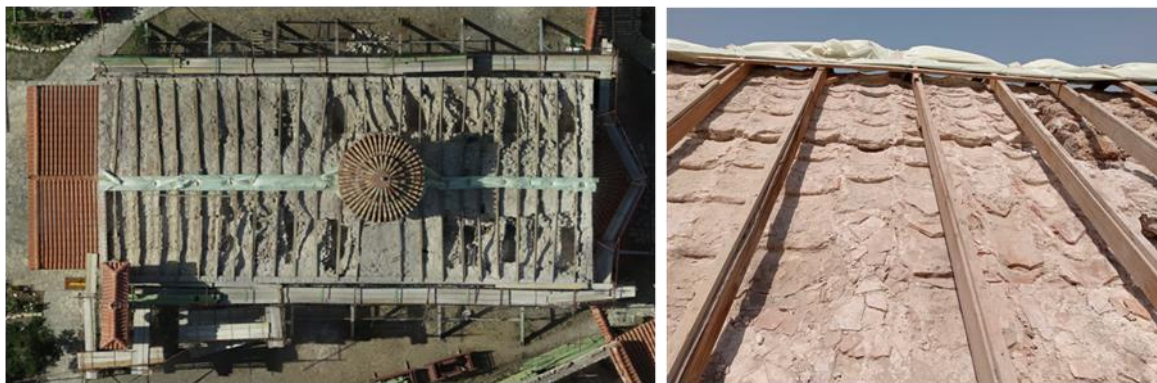
Figure 4: Revealed roof construction (left: orthomosaic, right: detail of construction)

The roof of the Temple consists of a vaulting system that is composed of domes, semi-domes and groin vaults, which rest on columns and pillars. During the repair works, the roof was opened, and its construction was revealed (Figure 4). It is a complex system of the newer phase, in which the slope of the roof is formed by stone gables, the gaps between which are bridged with wooden logs. The gaps are filled with stones and mortar. Stone slabs, wooden logs, slats and tiles were placed on top.

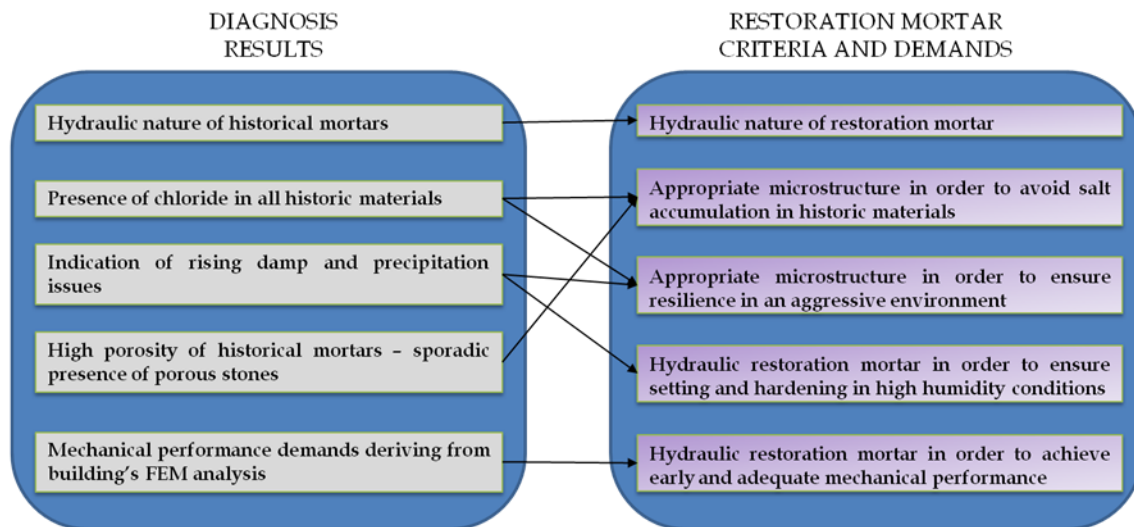
Figure 15: Diagnosis results and resulting restoration mortar criteria and demands

Taking into account the results of the diagnosis stage (as well as NDT results, section 3.3.), as well as the finite element model of the structure in its current state and for different repair scenarios (section 3.4.), a number of criteria arose, which were taken into account during the design and selection of the restoration mortar, in order for it to be compatible and performing (Figure 15). It should be noted that researchers have indicated that lime-pozzolan mortars seem to present the appropriate microstructural characteristics, rendering them resilient in corrosive environments (Theologitis et al., 2021; Moropoulou and Bakolas, 1998; Maravelaki-Kalaitzaki et al., 2005; Groot, 2016); furthermore, in high humidity environments, hydraulic mortars are not only more appropriate on account of their hardening mechanism (through both carbonation and hydration) (Maravelaki-Kalaitzaki et al., 2005), but also seem to perform better and present higher durability and resilience (Groot, 2016).

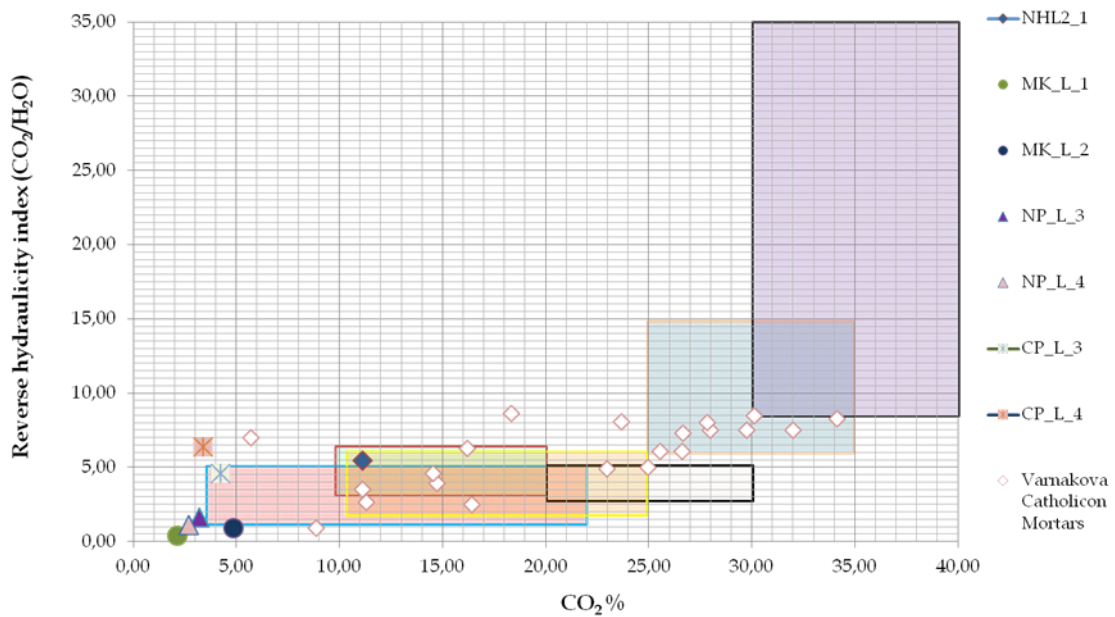
Figure 17: Thermal analysis results and correlation of CO<sub>2</sub> (%) loss with Reverse hydraulicity ratio of restoration mortars with acceptability limits and the historic mortars of the Varnakova Catholicon Monastery

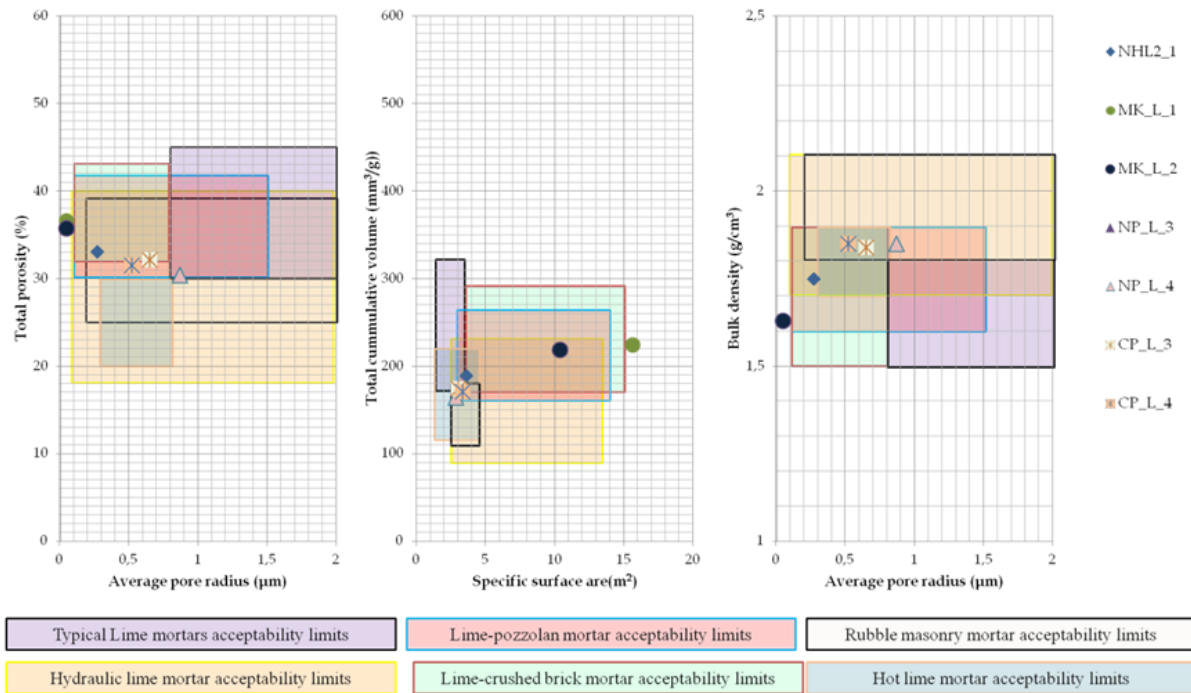
Figure 18: Mercury intrusion porosimetry results and correlation of microstructural characteristics of restoration mortars with acceptability limits

mortars which have shown good resilience under aggressive environments (Figure 18) and specifically lime-pozzolan mortars in accordance to Moropoulou and Bakolas (Moropoulou and Bakolas, 1998), where the lime-metakaolin and natural hydraulic lime mortars in the case under examination, show the best compliance; (iv) their mechanical strength acquisition during setting and hardening (Figure 19), where the lime-metakaolin mortars show the highest and earliest acquisition of mechanical strength; and (v) the volumetric shrinkage the restoration mortars present, which must be as low as possible in order to avoid microcrack formation during the application of the material (Aly and Pavia, 2015; Pozo-Antonio, 2015), where the lime-metakaolin mortars present the lowest values (Figure 20).

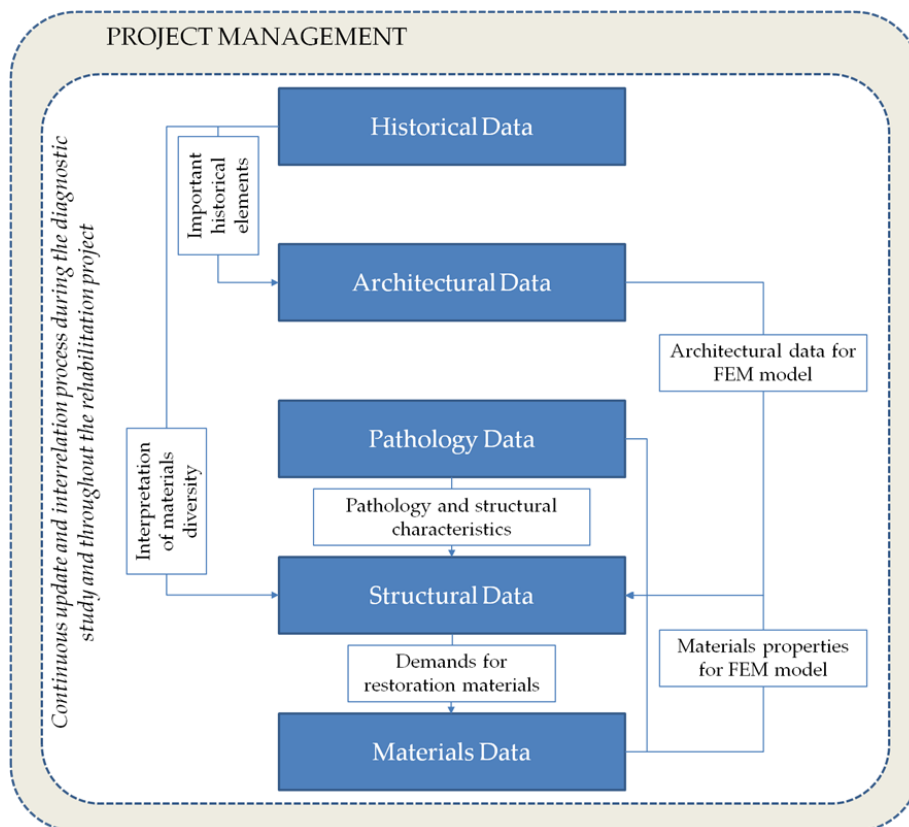
The methodological approach and the interrelation of all disciplines, which emerged from this study is presented in the following figure (Fig.21):

Figure 21: Transdisciplinary methodological approach for diagnosis and rehabilitation of historical structures
